Service Bulletin

PRELIMINARY INFORMATION

Subject: Hood Flutter, Shake or Vibration at Highway Speeds or over Rough Road Conditions

Models: 2015-2017 Cadillac Escalade, Escalade ESV
2014 Chevrolet Silverado 1500
2015-2017 Chevrolet Silverado, Suburban, Tahoe
2014 GMC Sierra 1500
2015-2017 GMC Sierra, Yukon, Yukon XL

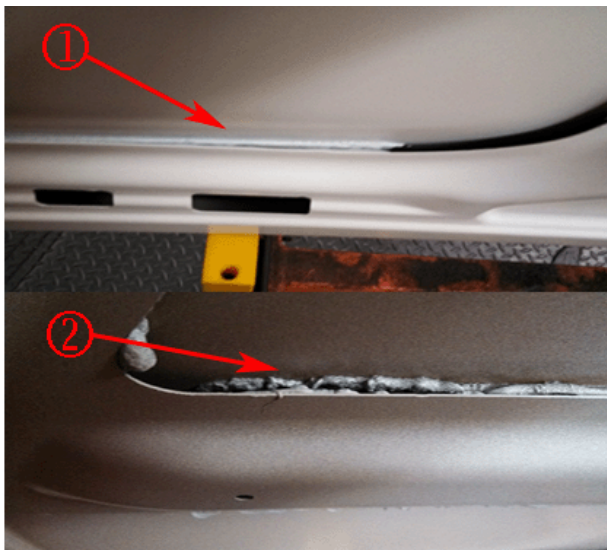
The inner and outer hood panels may not be sufficiently bonded together at all points. At highway speeds or over rough surfaces, the sheet metal may be able to flutter at some locations.

1. Separation
2. Gap/Void

Apply panel vibration control material between the inner and outer panels. The procedure below outlines the proper repair instructions. The accompanying illustrations show the most likely areas that may be the source of the fluttering.
