NUMBER: 23-015-16

Water On Front Carpet Or In Rocker Side Sill

2015 - 2016 (KL) Jeep Cherokee

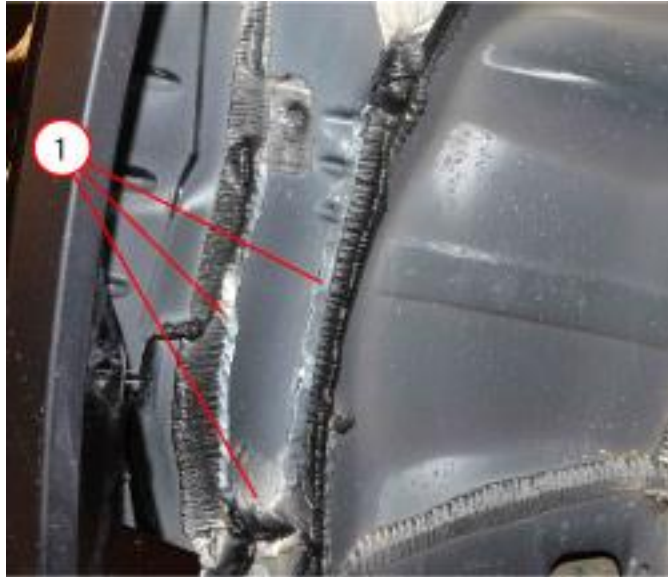
Fig. 4 Apply Kent Sealer

Right side shown, left side similar

1 - Apply on seam locations

- Using seam sealer (Kent products High-Tech clear #P10200 or equivalent), repair gaps in sealant ([Fig. 4](#)). You may have to cut away portion of vinyl sealer to expose and seal the leak path.

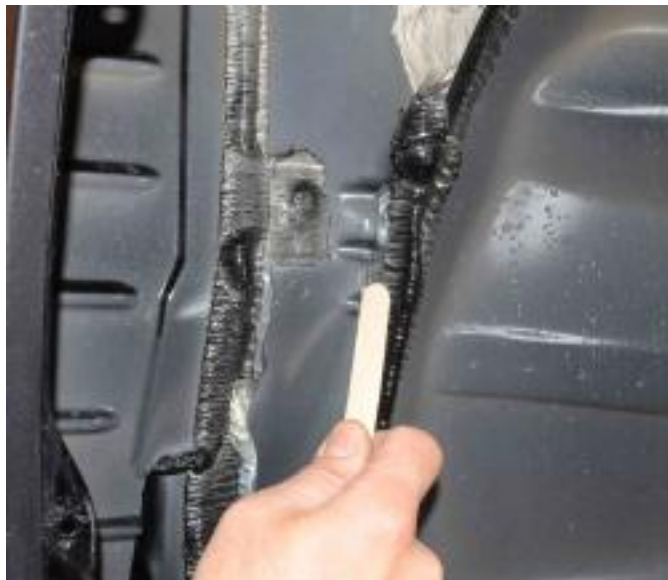
Fig. 5 Smooth Sealer With Wood Stick

Right side shown, left side similar

- Smooth out newly applied sealer with wood applicator ([Fig. 5](#)).
