SERVICE BULLETIN

APPLICABILITY: 2015-2016MY Legacy and Outback
 2015-2016MY Impreza and XV Crosstrek
 2015-2016MY Forester
 2016-2017MY WRX

NUMBER: 15-198-16
DATE: 05/02/16

SUBJECT: Reprogramming File Availability to Address Operational Concerns with “Gen 2” Fujitsu-TEN (F10) Navigation and 7” Display Audio Units

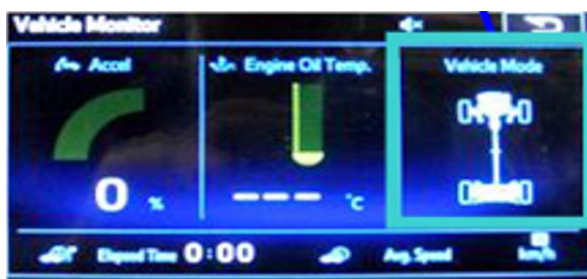
- Logic change to provide a “_” (underscore) character on the keyboard.
- Logic change to match the engine oil maintenance remaining mileage on the maintenance reminder screen to the odometer meter value on the combination meter when mileage unit is set to read in “KM”.
- Logic change to insure the Vehicle Mode indicator on the Vehicle Monitor screen matches the actual vehicle status. Example: The wheel indicators on the vehicle monitor screen no longer stay illuminated indicating VDC is “active” after VDC activation is complete.

VDC “Inactive”

This bulletin announces reprogramming file availability and the software installation procedure to address a group of operational concerns received from the field listed below involving “Gen 2” F10 Navigation and Display Audio units with 7” display. The procedure will involve downloading the applicable software update files from Subarunet then loading them onto a flash drive for audio unit installation. It is important to read through and understand this information **completely** before proceeding.

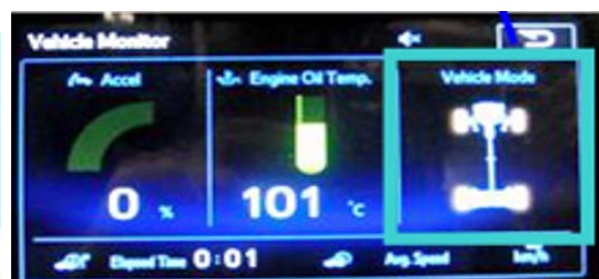
VDC “Active”
