SERVICE BULLETIN

APPLICABILITY: 2005-09MY Legacy and Outback Models **NUMBER:** 12-197-16R
SUBJECT: Melting / Sticky Dashboards / Instrument Panel (IP) **DATE:** 02/25/16
REVISED: 05/06/16

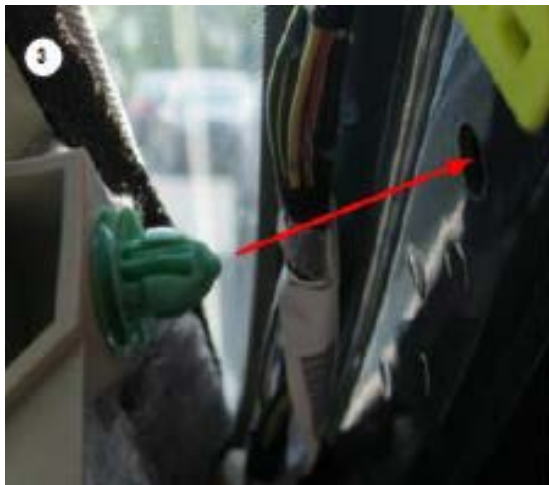
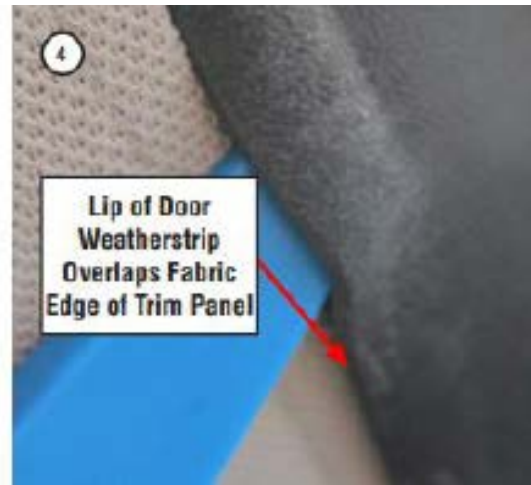
- When removing the “A” pillar trim, be **VERY CAREFUL** not to damage the upper metal retaining clip (see photos below). The clip is located just below where the trim panel meets the head liner. If the metal retaining clip becomes damaged or separated from the trim panel, the “A” pillar trim panel **MUST** be replaced as the clip is not available separately. **DO NOT** attempt to straighten or reuse the clip if it becomes damaged. Use a plastic trim tool to push down (1 & 2) and release the upper portion of the metal clip from the body. Be careful to not pull the trim panel open any further than necessary to gain access for releasing the clip. There is also a plastic retaining clip (3) in the lower portion of the trim panel which will release easily once the upper retaining clip is loose. At reassembly and using a plastic trim tool, make sure the inner lip of the door weather strip overlaps the outer fabric edge of the trim panel (4) to help secure it.

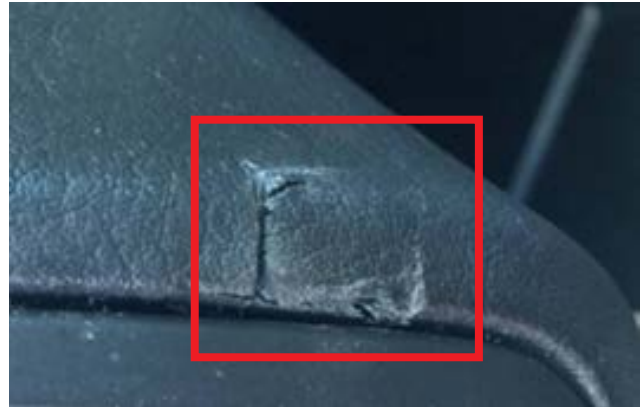
- When removing the center vent / storage box assembly, **CAREFULLY** release the 3 retaining claws shown in the illustration below using a plastic trim tool. Always support the trim tool against the IP (example: a second trim tool placed horizontally between the first tool and the IP) to distribute the prying force and avoid damage as shown in the example photo. Remember to disconnect (and reconnect) the trip computer's wiring harness connector.

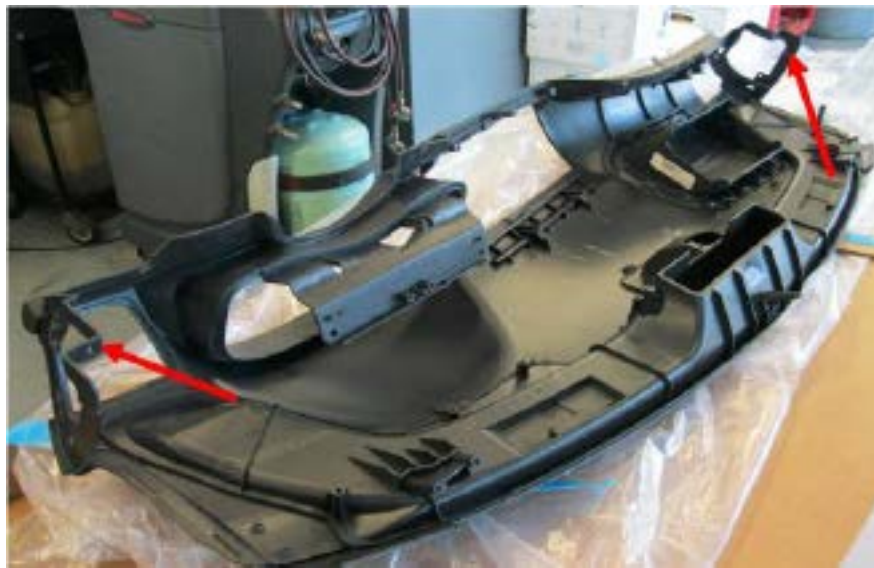
- Always use caution when removing the new IP from the plastic shipping bag. Pay close attention to the mounting brackets on each end of the new IP as indicated in the photo below. They can easily be broken if the heavy plastic shipping bag is removed too hastily.

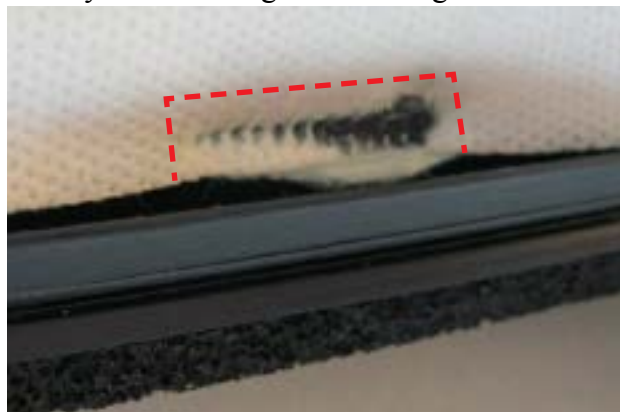
- As shown in the photo above, the replacement IP does not include the white insulation material. Although the ductwork does the bulk of holding the insulation in proper position, there are a few places where it is heat-fused as shown in the photo below to the original part. **CAREFULLY** cut around the fuse point with a small utility knife or scissor to release it then pull the insulation away from the original IP taking care to not tear it.

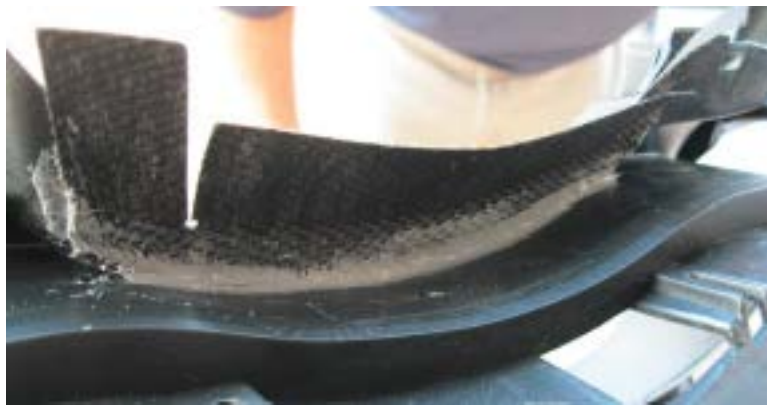
- Once the cover is removed, a **VERY** small amount of black or clear silicone sealer / adhesive works well to “tack” it into position on the new IP. Once in place, a small “fillet” of black or clear silicone can be applied from the back side as shown below to fully secure it in place. (Gray was used for photo.)

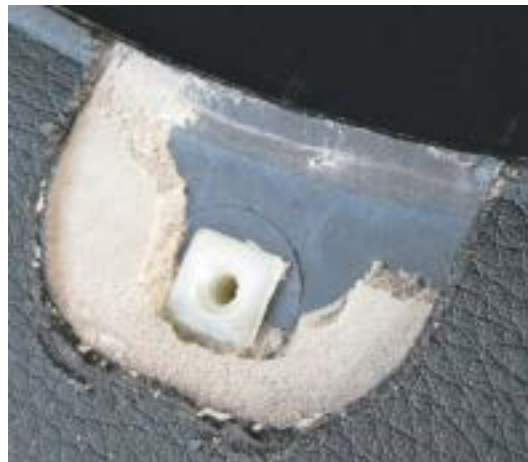
- **VERY CAREFULLY** using the molded-in groove as a guide, trim the IP as shown to gain access to the square hole for the combination meter top retaining screw clip. After cutting, peel away the trim surface then the foam underneath it to access the square hole for the clip.

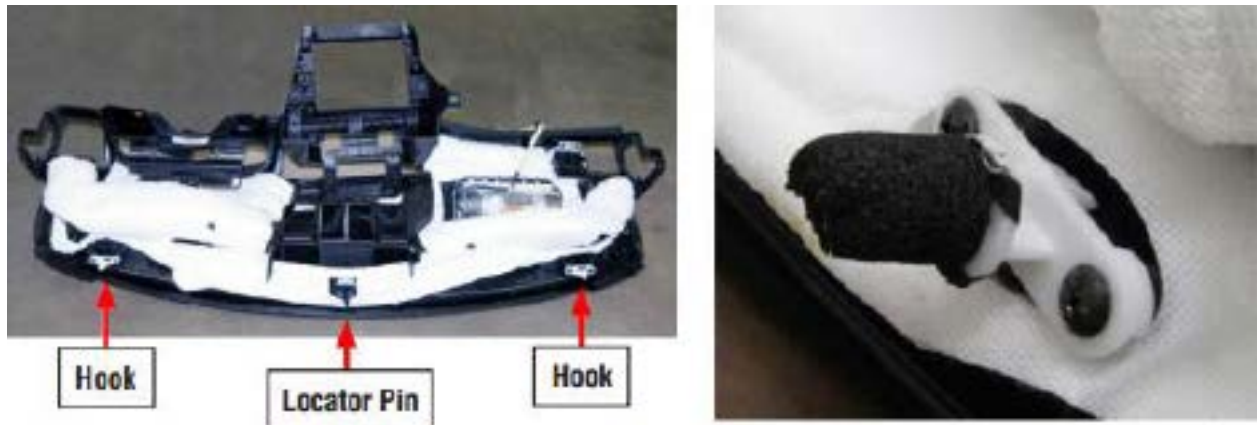
- Before installing the new IP, to eliminate a possible source of a rattling sound, wrap both hooks and the center locator pin with non-woven material, p.n. SOA963W110 (or an equivalent self-adhesive foam) as shown in the photos below.
