REPAIR PROCEDURE

APPLICABILITY: 2016-2017MY Legacy and Outback
SUBJECT: Inspection and Repair Procedure for Stop Sale / Recall Campaign
 WTD-65: Steering Column

NUMBER: WTD-65R
DATE: 05/10/16
REVISED: 05/17/16

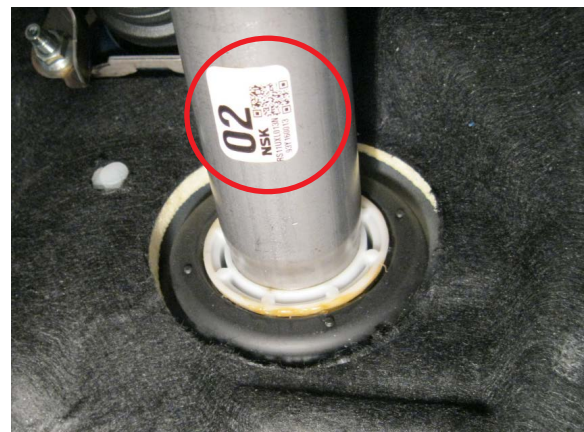
- Locate the lot number label at the base of the steering column located just above the toe board grommet as shown in the photo below.

For KEY START models, the label will have a large “02” as shown in the photo.
 For PUSH START models, the label will have a large “03”.

The steering columns are **NOT** interchangeable.

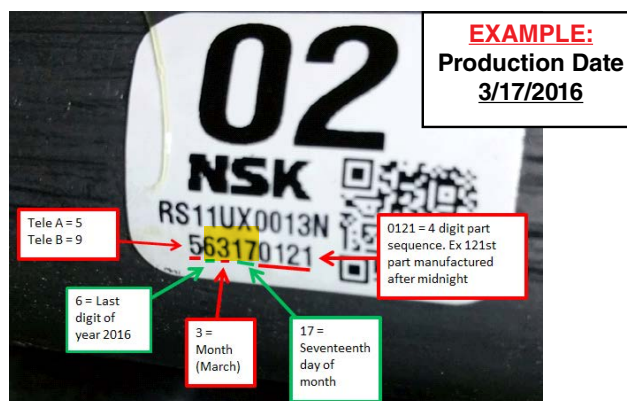
- Decode the lot number of the steering column using the illustration below.
- **Affected steering columns will have a lot number label indicating the column was produced on or between 6228 (February 28, 2016) and 6416 (April 16, 2016), the steering column assembly must be replaced.**
- If the lot number is illegible or otherwise cannot be determined, it must be noted on the repair order and the steering column assembly must be replaced.

- **IMPORTANT:** Always record the original lot number on the Repair Order even if it is outside the affected range. **The ORIGINAL 4-digit lot number must also be entered in the Miscellaneous Detail field when submitting for claim reimbursement. If illegible, enter “ILLEGIBLE” in that field.**
