SERVICE BULLETIN

APPLICABILITY: All 2015-17MY Vehicles with Fujitsu TEN (F10) 7in. Multimedia Navigation (AVN) & Display Audio Units
NUMBER: 15-177-14R
DATE: 10/16/14
SUBJECT: “Gen 2” & “Gen 2.1” Operating Tips
REVISED: 05/18/16

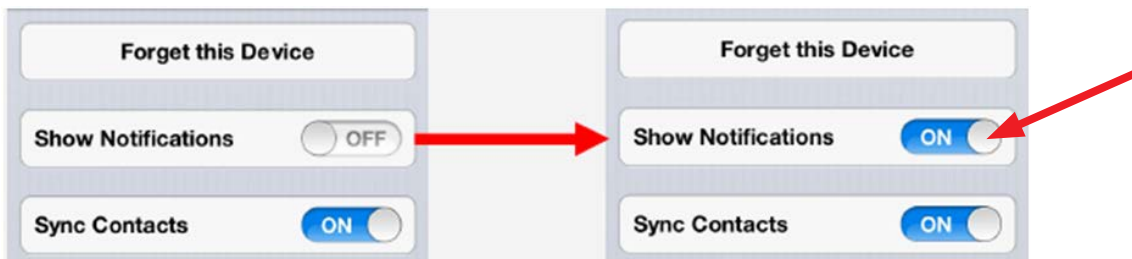
CONDITION #1: Cannot receive incoming text messages on the head unit when using an iPhone.

“Show Notifications” is not activated in the iPhone’s Bluetooth Settings menu.

4. Slide “Show Notifications“ button to “ON”.

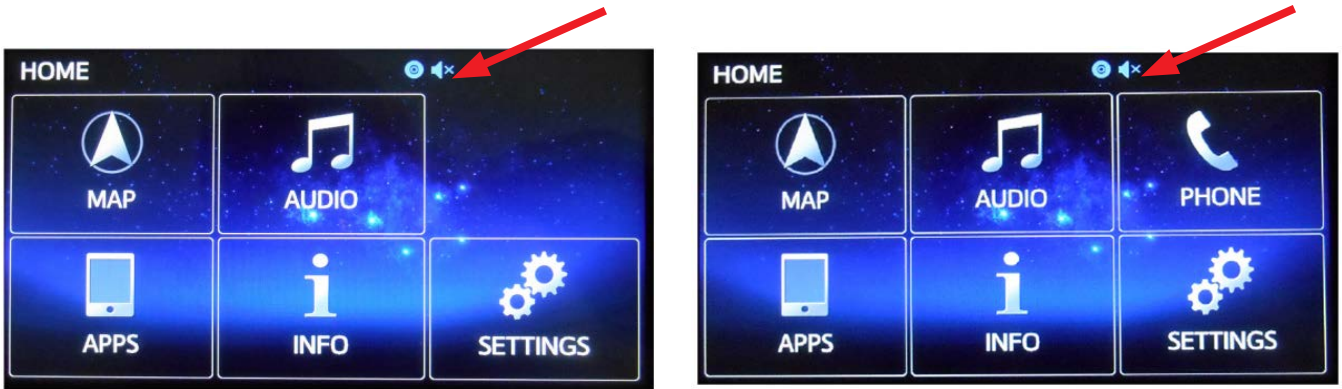
CONDITION: #5: A “Phone” button is not displayed on the HOME screen.

- Microphone is not properly connected to the head unit
- Microphone detection wiring (MIC DET) is open
- Microphone unit is defective

- Confirm the microphone wiring is securely connected to the head unit.
- Confirm there is not an open circuit or short in the Microphone detection (MIC DET) wiring.
- After the wiring has been confirmed to be OK, replace the microphone if necessary.

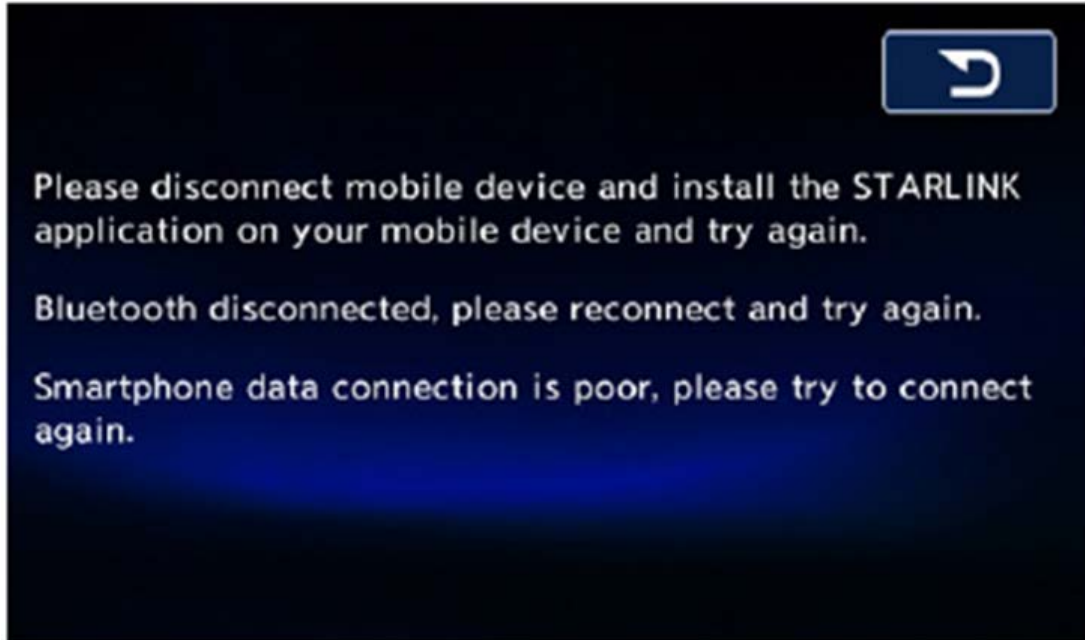
CONDITION #8: When selecting the STARLINK function on the head unit, an error message appears on the screen as shown below.

- STARLINK application on the Smartphone was not loaded and/or launched on the Smartphone prior to selecting the STARLINK function on the head unit. Therefore, Smartphone cannot communicate with STARLINK Server.
- Smartphone has not been paired with the head unit for Bluetooth connection

- Check if Bluetooth connection indicator appears as shown below on the screen of the head unit. If not, the Smartphone needs to be paired to the head unit via Bluetooth connection.

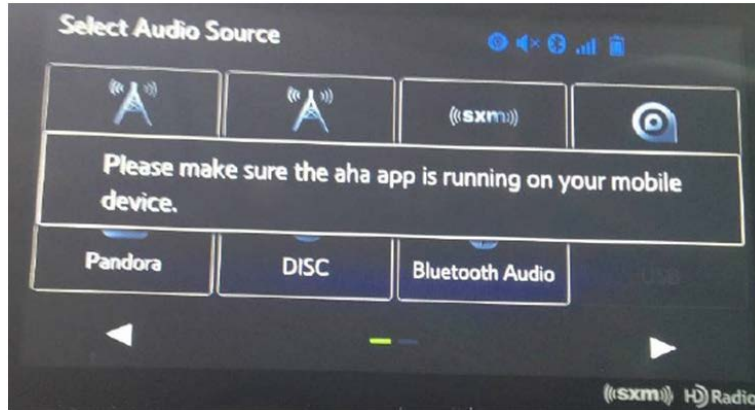
aha Message

CONDITION #10: When selecting aha or Pandora on the head unit with a Smartphone (iPhone or Android) connected, the head unit displays a message informing the user to check the app on their Smartphone (see below).

- Pandora or aha App is not installed on the Smartphone.
- Pandora or aha App is not launched on the Smartphone.
- The iPhone is not connected to the system to the head unit with a USB Cable or in the case of an Android Smartphone, the Smartphone is not paired to the head unit using Bluetooth or launched.

- Download the Pandora or aha app to the Smartphone.
- Launch the Pandora or aha app on the Smartphone.
- Connect the iPhone to the head unit using a USB cable.
- Pair the Android phone to head unit using Bluetooth.
- Select Pandora or aha on the head unit from Audio Source

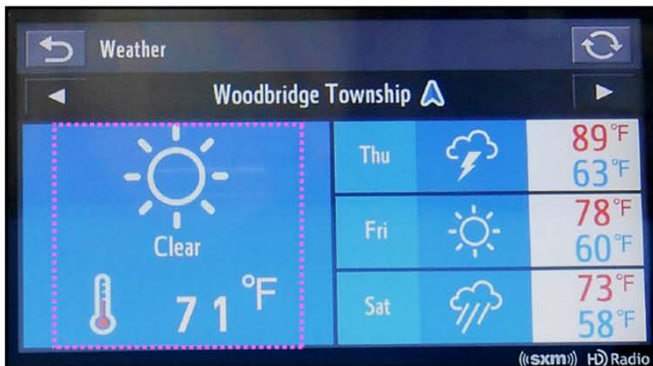
Weather information via STARLINK

CONDITION #11: Weather information from the “STARLINK” and “INFO” function appears to be different even when the time of day and location are exactly the same.

In the examples shown below, the temperature displayed is different even though the time of day and location are the same.

The source of the weather information is different between STARLINK and INFO. STARLINK utilizes weather information provided by Weather Underground while INFO utilizes Sirius XM.

Explain to the customer that the STARLINK and INFO functions utilize different sources to provide the displayed weather information as shown in the illustrations below.

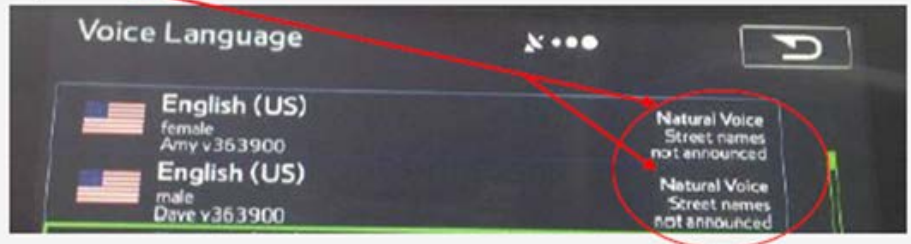
Figure 1

CONDITION #12: When using the voice command to operate navigation system functions, the following message is displayed: “This feature cannot be used with the selected guidance voice profile”.

“Natural Voice” (Figure 1) is selected from the Voice Language menu when “Text To Speech” (TTS) is required (Figure 2) for proper voice command operation.

- Follow the steps below to change from Natural Voice to TTS:
 1. Select “Home”.
 2. Select “Settings”.
 3. Select “General”.
 4. Select “Language”.
 5. Select “English (US) TTS Voice”.

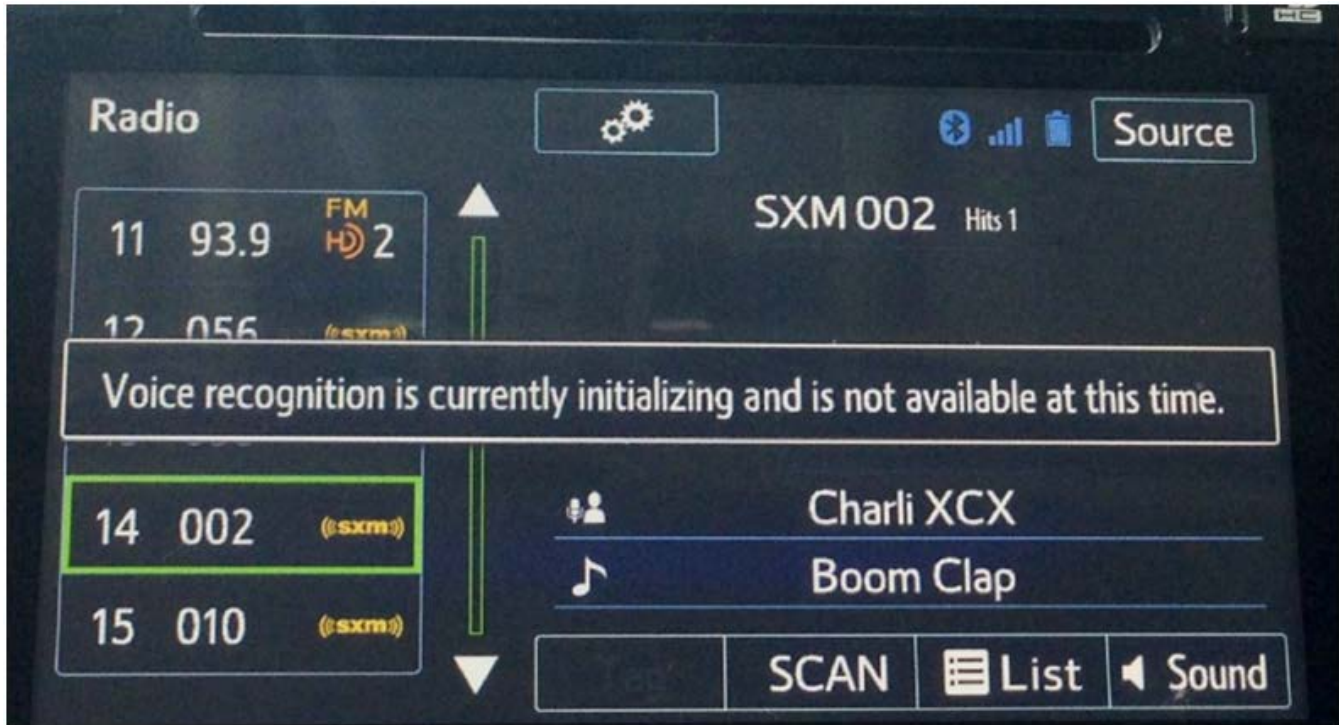
CONDITION #15: The message “Voice recognition is currently initializing and is not available at this time” appears on the screen.

When the head unit is turned on, the system scans XM stations along with every song (digital file) on the currently loaded CD, connected USB device and / or Bluetooth Audio player. It also scans the phone contacts stored on all Bluetooth-connected Smartphones. The system then creates voice tags for all the XM station names, artists, songs, albums, playlists, podcasts, genres, and contacts. During this process, the head unit will also display “Voice Recognition is currently initializing and is not available at this time” (see picture below).

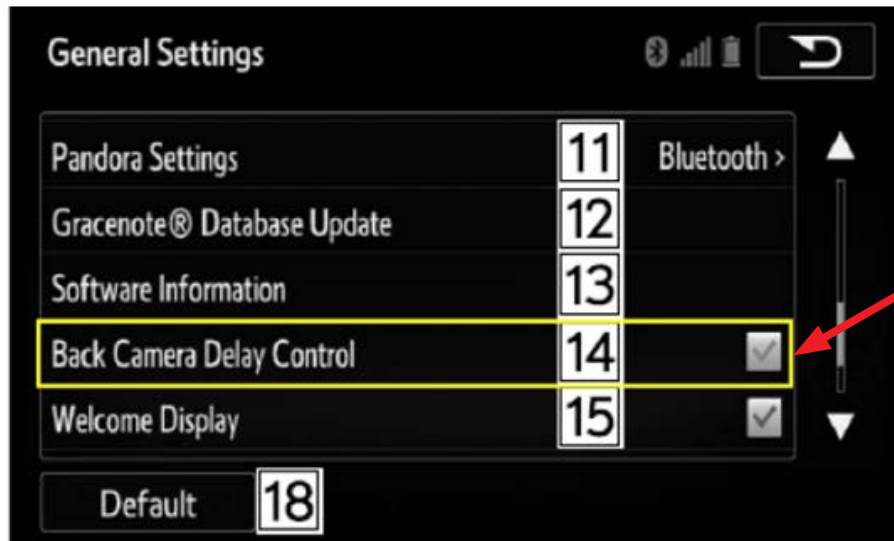
CONDITION #17: Back-up camera image remains displayed after shifting out of Reverse

“Back Camera Delay Control” setting is set to “ON”

When set to “ON”, the back-up camera image will remain displayed for about 7 seconds after moving the shifter out of Reverse. The image will turn off when shifting into Park or when vehicle speed exceeds 5 mph.

1. Touch “HOME” button.
2. Touch “SETTINGS” button.
3. Touch “General”.
4. Unselect the “Back Camera Delay Control”.

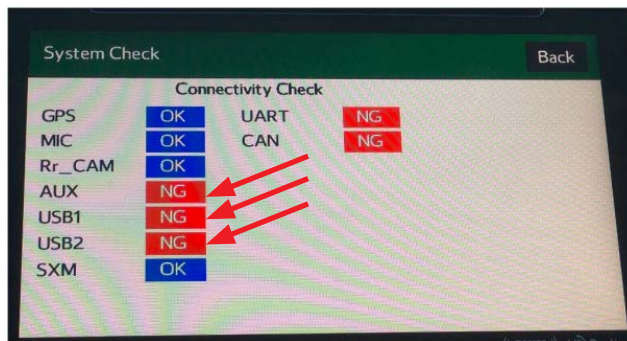
CONDITION #18: When in Diagnostic Mode, AUX, USB1 and USB2 all show as being NG

To access Diagnostic Mode, follow the steps below:

- Turn the ignition switch to ACC (or press the Engine Start Stop button).
- While pressing and holding the “a” button, press the button “b” twice.

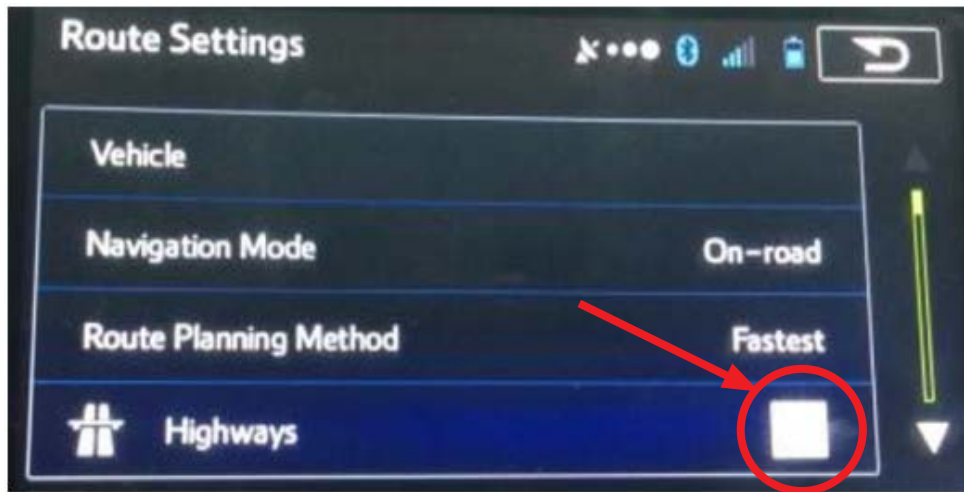
CONDITION #20: The Navigation system often routes the user off the highway, and onto rough surface (dirt / gravel) roads.

In the Route Settings menu, the “Highways” selection box is unchecked.

- Select “**Menu**” on the Map Screen
- Select “**More**”
- Select “**Settings**”
- Select “**Route Settings**”
- When “**Highways**” is checked the navigation system will always consider using highways first when planning routes.

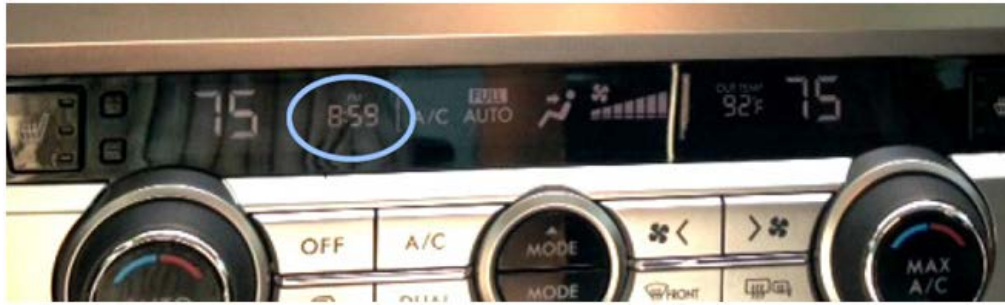
CONDITION #23: The clock display on HVAC panel is incorrect even when “Auto Adjust by GPS” is selected on the Clock settings menu.

The correct time is 4:59 pm but HVAC display shows 8:59 pm.

1. If the user wants to operate the AVN unit without the map SD card installed and still have the correct time shown on the HVAC panel, access the Clock settings menu, uncheck “Auto Adjust GPS” then manually reset the correct time using “+” and “-” buttons to the left of the clock display as shown below.

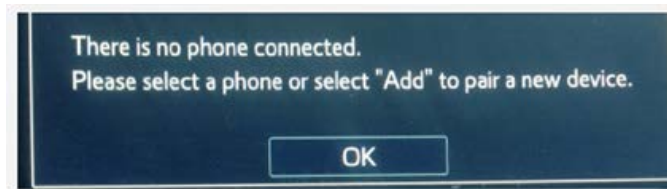
Pic 1

1. The message shown in (Pic 1) will display when there is no phone paired with the unit.

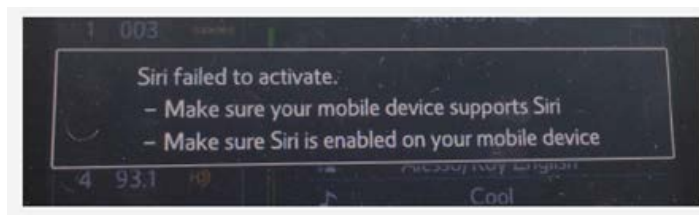
Pic 3

3. The message shown in (Pic 3) will display when a Siri-compatible phone is paired but “Siri” has not been enabled on the phone.

1. Go to “Settings”
2. Select “General”
3. Select “Siri”
4. Enable “Siri” (Pic 5)

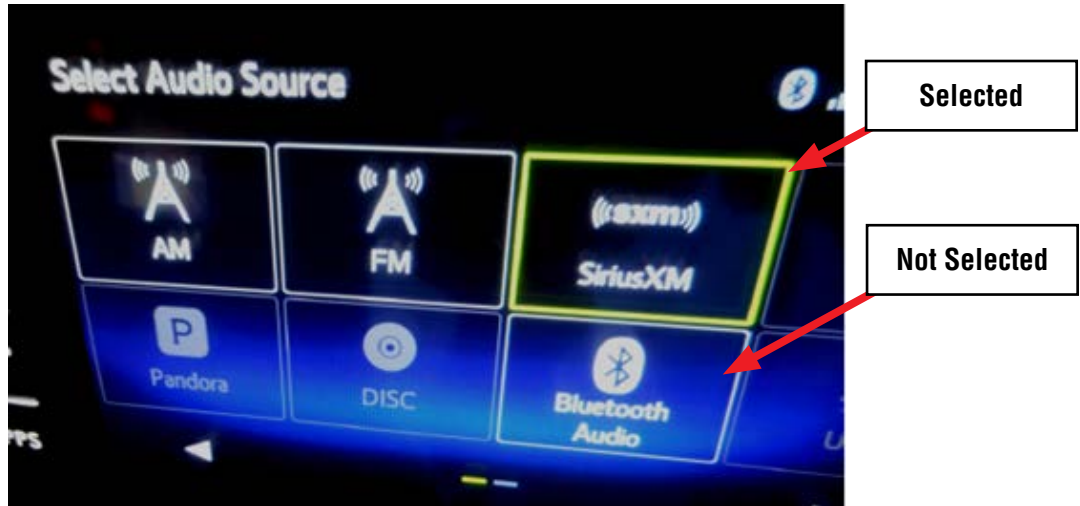
CONDITION #27: Navigation voice guidance cannot be heard from the vehicle speakers when the destination was requested by Siri (iPhone App) (2016 MY vehicles equipped with Gen 2.1 Navigation / Display Audio system)

Bluetooth Audio is not selected as an Audio Source.

From the Select Audio Source screen, select Bluetooth Audio then confirm the navigation voice guidance can be heard from the vehicle speakers normally.

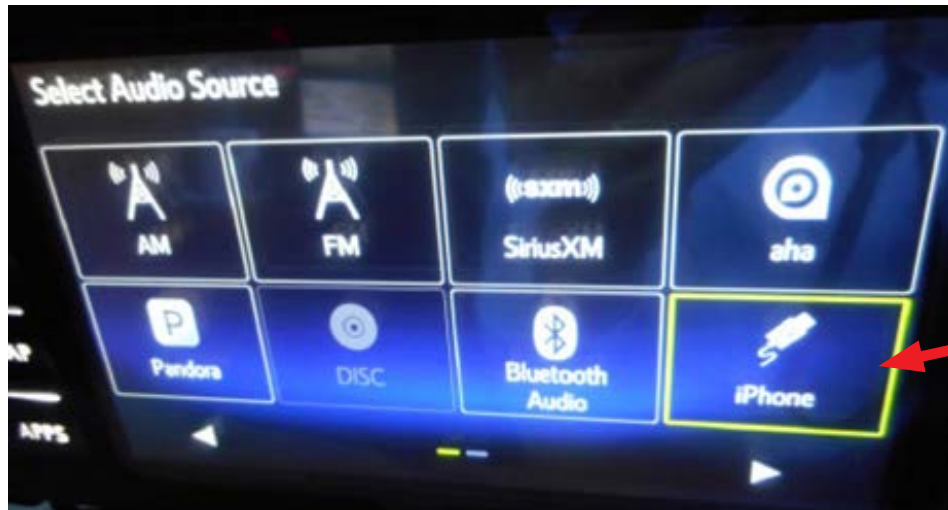
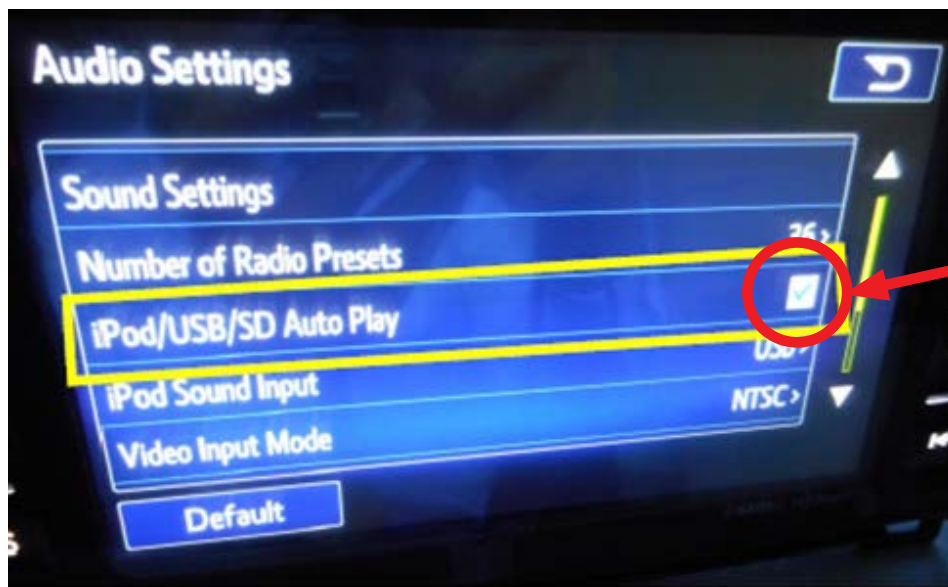
CONDITION #28: When connecting an iPhone to the USB port to charge it, the Audio Source automatically switches to iPhone.

If the unit automatically “defaults” to iPhone mode, the “iPod/USB/SD AutoPlay” setting is selected (activated / checked) on the Audio Settings screen.

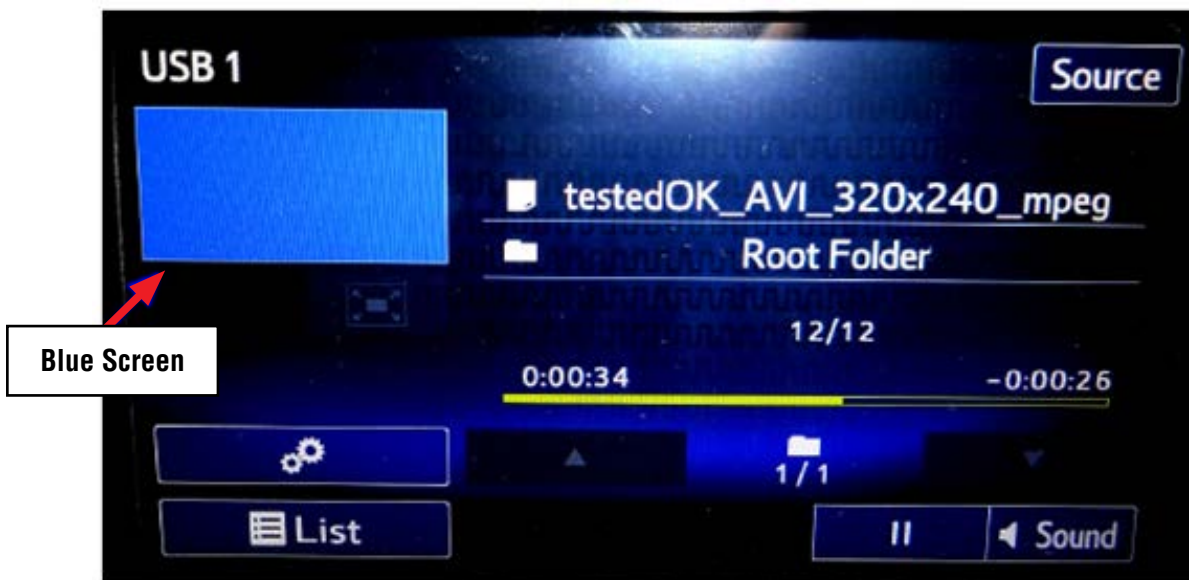
REMINDER: The parking brake must be engaged in order to watch videos. If not, the unit will display the blue screen as shown below but audio will be heard normally.

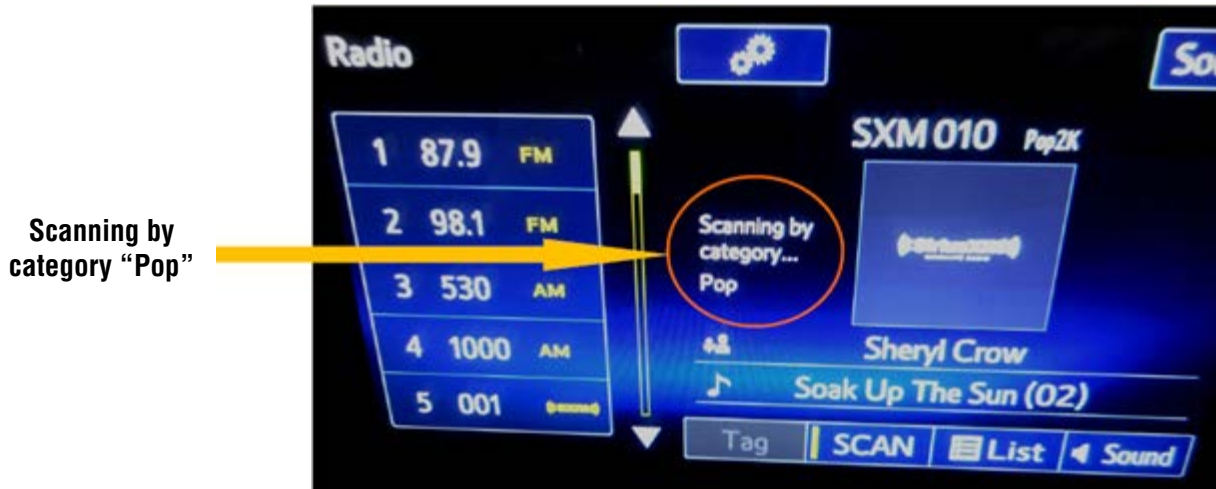
CONDITION #32: Cannot scan or seek through all SXM channels using the Seek, Scan and / or Steering Wheel buttons (2016 MY vehicles equipped with Gen 2.1 Navigation / Display Audio system)

EXAMPLE: If you are listening to CH2, which is under a “Pop” category, and press the scan button, it will only scan channels (CH3, 4, 5, 6, 7, 8, 9, 10, 13, 14, 15, 16, 17, 18, 158, 300, 301, 302 and 2) which are under the Pop category, not all channels or categories.

Use the “AUDIO/TUNE” knob to scan through all the SXM channels available.
