REPAIR PROCEDURE

APPLICABILITY: 2016-2017MY Legacy and Outback
SUBJECT: Inspection and Repair Procedure for Stop Sale / Recall Campaign
 WTD-65: Steering Column

NUMBER: WTD-65R
DATE: 05/10/16
REVISED: 05/23/16

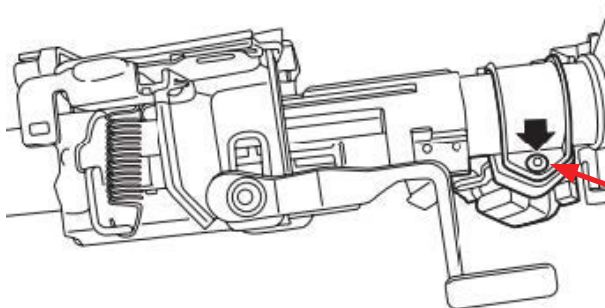
DO NOT apply any impact to the shear bolt when removing it (no hammers/chisels). Doing so will likely damage the Steering Lock Control Module (push start models).

- **CAREFULLY** remove the steering column assembly taking special care to not dislodge the toe board grommet / bushing.
- Using a **drill and screw extractor**, remove the shear bolt securing the ignition lock to the steering column.
