**NUMBER:** 09-007-16

Tighten Generator Mounting Bolts

This bulletin involves torquing the generator mounting bolts to proper specifications.

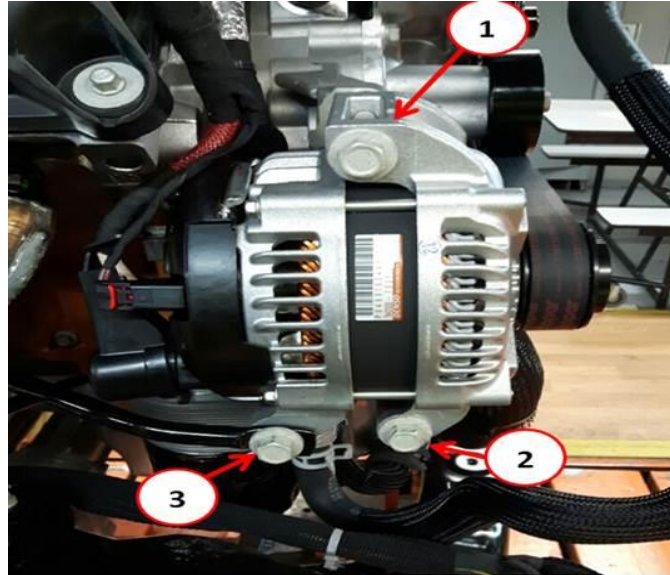
**Fig. 1 Generator Mounting Bolts**

The customer may hear a noise coming from the generator or possibly experience loss of charging.

1. Raise and support the vehicle. Refer to the detailed service procedures available in DealerCONNECT> TechCONNECT under: Service Info>04 - Vehicle Quick Reference/Hoisting/Standard Procedure>Standard Procedure - Hoisting.
2. Tighten all three generator mounting bolts to 54 N·m (40 ft. lbs.) (Fig. 1).
