NUMBER: 23-001-16 REV. D

GROUP: Body

DATE: April 19, 2016

Center Console Lid Binding

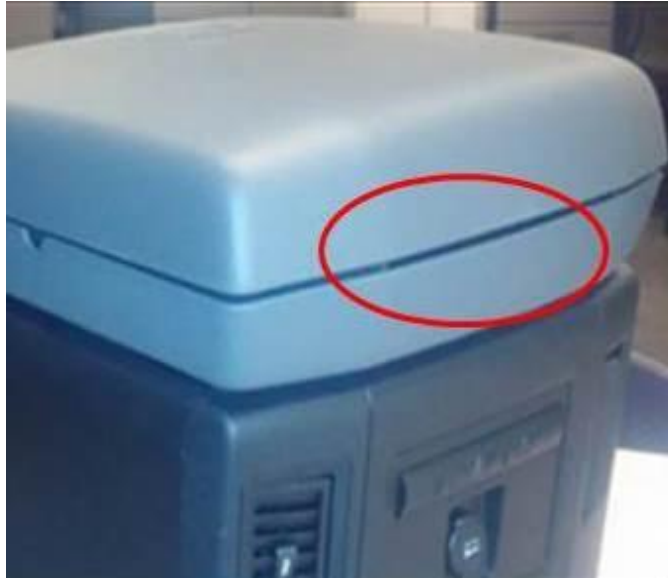
Fig. 1 Check Lid For Rubbing

1. Locate the center console inside the vehicle.
2. Slowly open the upper lid of the center console while checking the gap between the bottom of the upper lid and the top of the lower lid for rubbing together as shown in (Fig. 1).

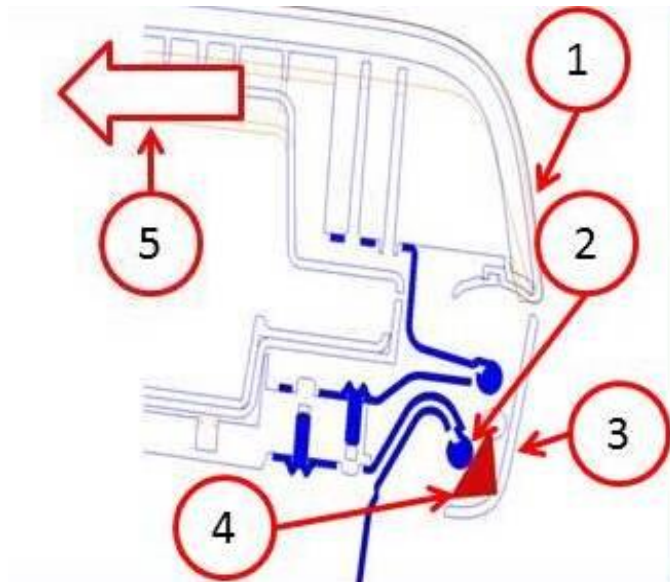
Fig. 6 Bumper Installation

- 1 - Rear Of The Center Console
 - 2 - Hinge
 - 3 - Lower Lid
 - 4 - Bumper
 - 5 - Front Of The Console
-

11. At the center of the console wall on the lower lid (as noted in the previous step), insert the bumper where the red triangle is shown. It will take some effort to push the bumper in flush with the edge of the lower lid as shown in (Fig. 6) and (Fig. 7).

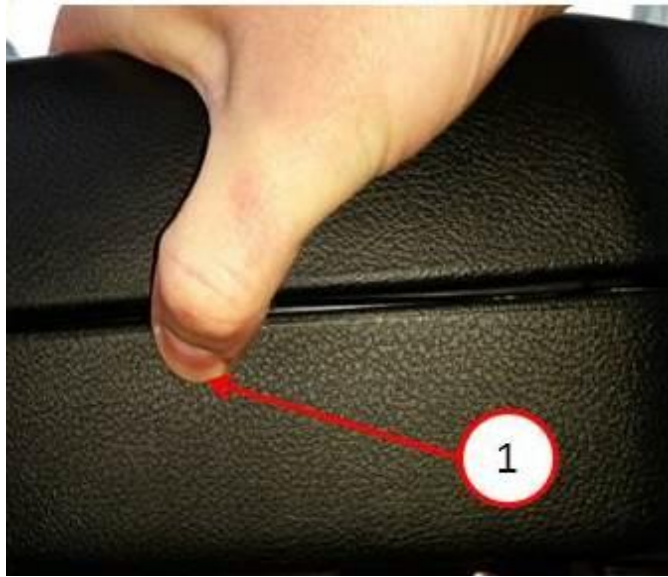
Fig. 8 Bumper Installation Continued

1 - Press The Back Wall

12. To assist the installation of the bumper, press the back wall of the lower lid to relieve some tension while inserting the bumper as shown in (Fig. 8).

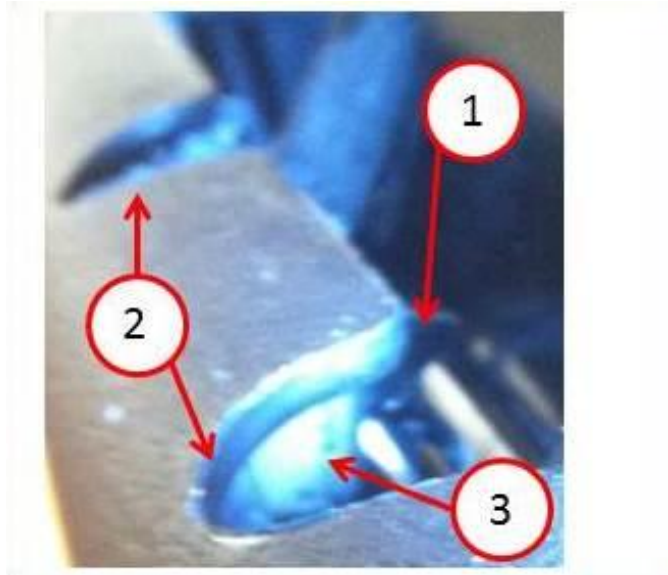
Fig. 9 Bumper Installed

- 1 - Metal Tab On The Lower Lid Hinge
- 2 - Notches
- 3 - Bumper Installed

13. Visually inspect the area of repair that the bumper is installed as shown in (Fig. 9).
