NUMBER: 08-039-16 REV. A

Transmission Wiring Harness Repair Or Replacement For No Start Or Stiff Steering

2014 - ****2016**** (KL) Jeep Cherokee

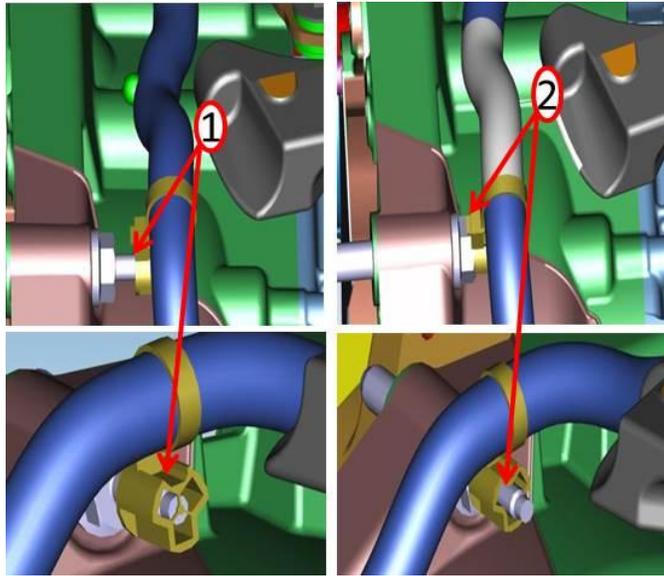
Fig. 1 Clip Location

1. ****This step applies to Sales Code NBC only.**** Inspect the existing clip to be fully seated. The existing clip has a stop/cap that currently keeps clip at top of stud. This clip must be pushed in completely onto the stud past the stop/cap. This can be attained by little force to break the stop/cap plastic stop (Fig. 1) & make sure the locking C clip is secured (Fig. 2).

1 - Present Position

2 - Proper Position

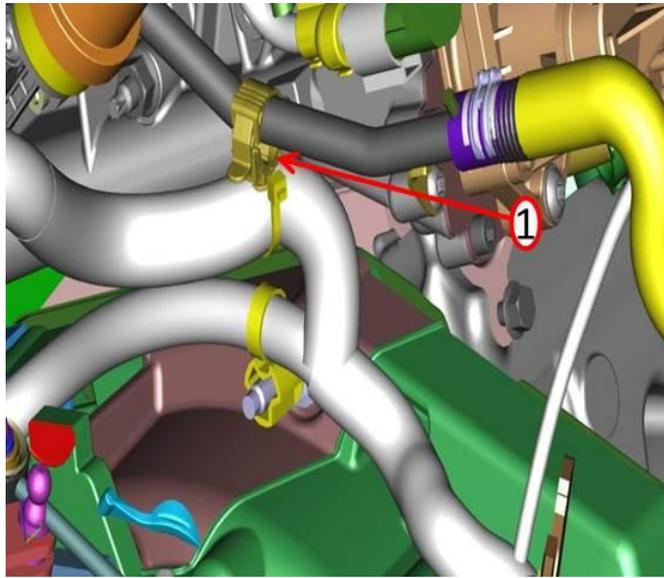
Fig. 2 Locking C clip

1 - Locking C-Clip

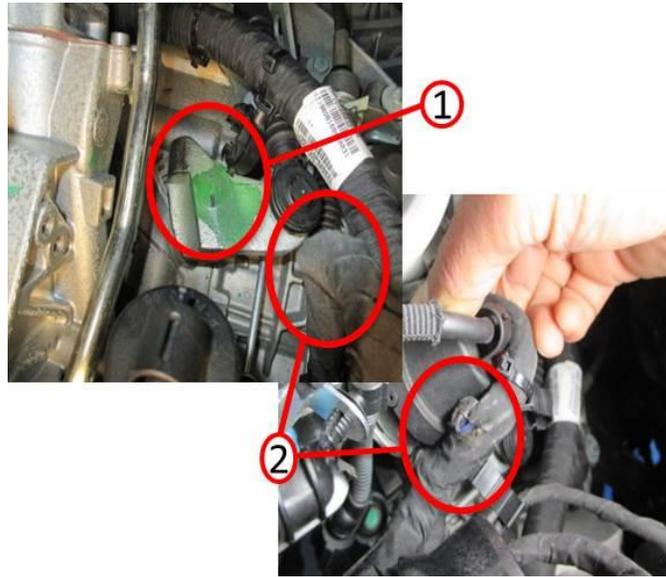
Fig. 3 Contact Areas

2. ****This step applies to Sales Code NBC only.**** Inspect the wiring harness at these locations for rub through or chaffing of the wires ([Fig. 3](#)) & ([Fig. 4](#)).

- 1 - Contact area 1 top side of engine transmission harness toward the rear cylinder head
2 - Contact area 2 top side of engine transmission harness
-

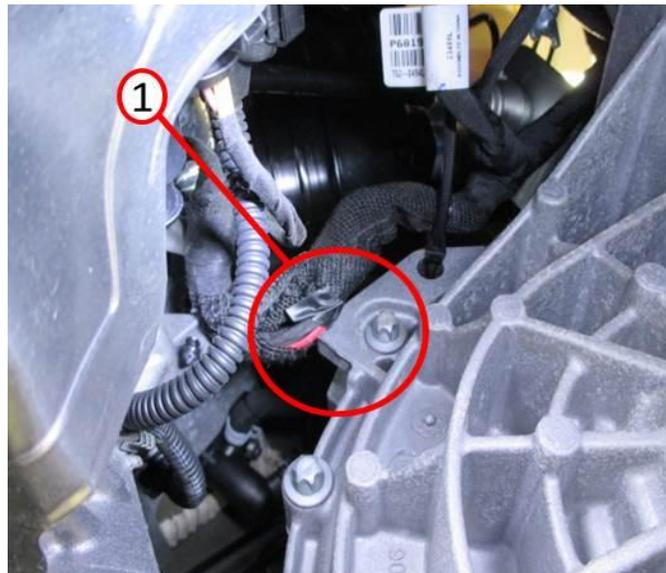
Fig. 4 Contact At Trans

- 1 - Euro 5 Shown / Euro 6 Similar
-

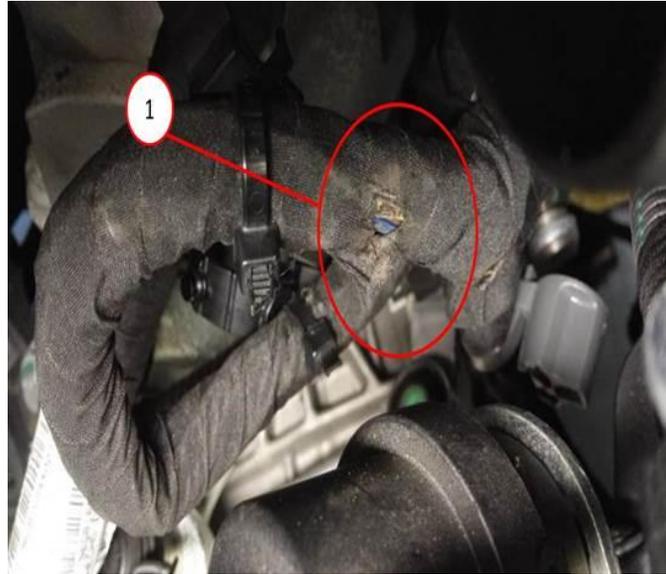
Fig. 5 Rub Area

3. Is there chaffing of the wires (Fig. 5)?

1 - Possible Rub Area

-
- a. YES>>> Replace wire harness proceed to [Step #4](#) and install mastic tape patch ([Fig. 6](#)) at the wear location ([Fig. 7](#)).
 - b. NO>> Install mastic tape patch ([Fig. 6](#)) at the wear location ([Fig. 7](#)). Proceed to [Step #24](#).

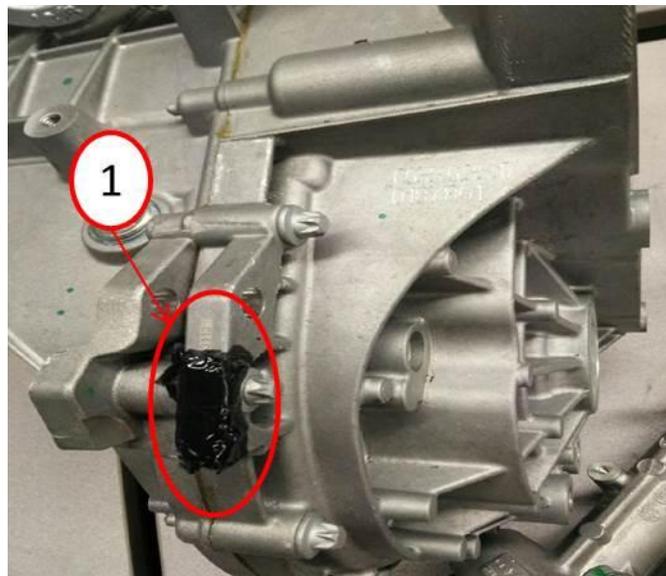
Fig. 6 Mastic

1 -Mastic Tape Repair

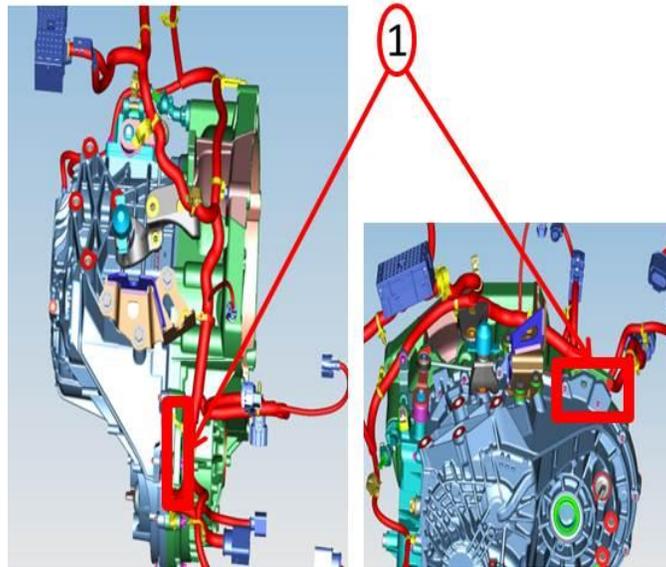
Fig. 7 Mastic Patch

1 - Mastic Patch Area

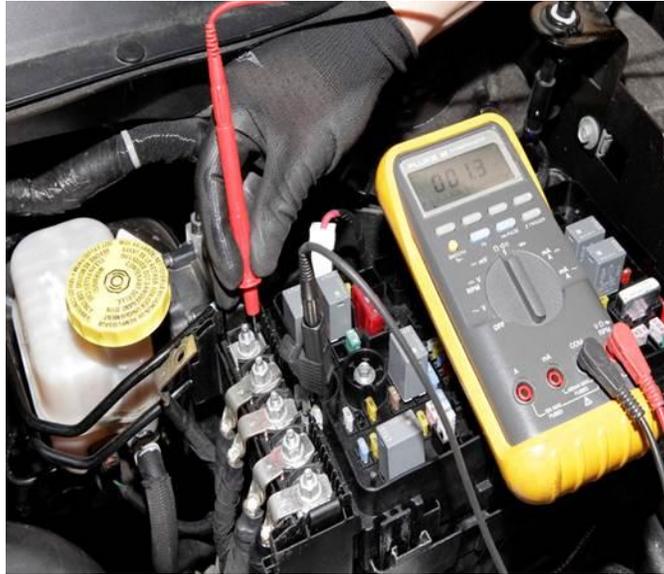
Fig. 13 Ohm Testing Fuses

17. OHM test the fuses (Fig. 13). Are any of the fuses bad/open?

- a. YES>> Replace the bad fuse(s) (Fig. 14) after the wiring harness has been replaced. Proceed to [Step #18](#).
- b. NO>> No further action needed with the fuses. Proceed to [Step #18](#).

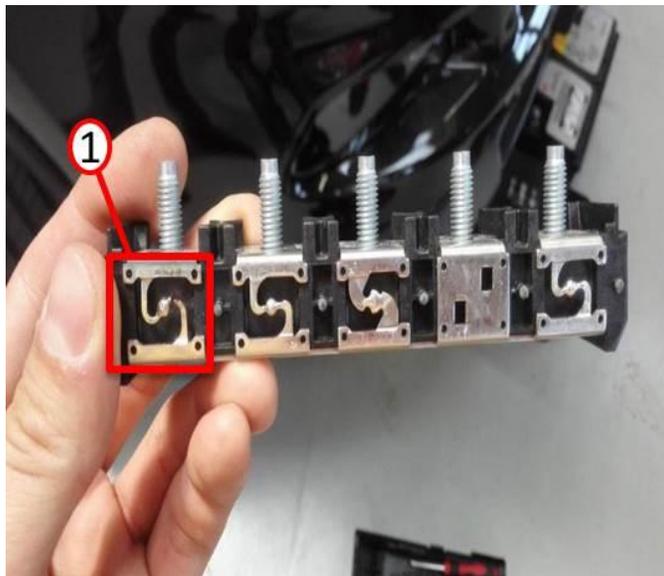
Fig. 14 Fuse

1 - Bad Fuse
