NUMBER: 23-031-16

DATE: June 22, 2016

RamBox Lid Left Applique Loose

2016	(DS)	Ram 1500 Pickup
2016	(D2)	Ram 3500 Pickup
2016	(DJ)	Ram 2500 Pickup

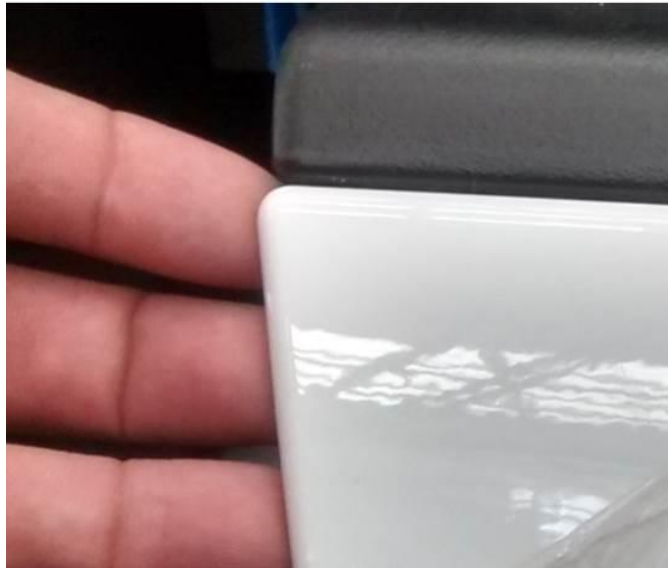
Fig. 1 Applique separation

Applique may separate at lid, due to insufficient adhesive bond strength.

1. If the left applique separation is visible anywhere at the lid ([Fig. 1](#)), the affected applique will need to be replaced.

2. Was any seam separation found at the RamBox lid applique?
 - a. YES>>> Replace and paint the affected applique as required if signs of separation are shown. Proceed to [Step #3](#).
 - b. NO>>> Applique separation from the lid was not found. This bulletin has been completed. Use LOP (23-09-09-97) to close the active RRT.
3. Replace the applique. Refer to the detailed service procedures available in DealerCONNECT> TechCONNECT under: Service Info>Refer to 23 - Body/Exterior/BOX, Pickup/Removal/Installation>RamBox Applique for the applicable procedure.
4. Applique comes primed and must be painted to match body color.
5. Which type of basecoat will be used?
 - a. Solvent basecoat >>> proceed to [Step #6](#).
 - b. Waterborne basecoat >>> proceed to [Step #10](#).
