SERVICE BULLETIN

APPLICABILITY: All 2015-16MY Vehicles with Fujitsu TEN (F10) 7in.

SUBJECT: "Gen 2" & "Gen 2.1" Operating Tips

NUMBER: 15-177-14R

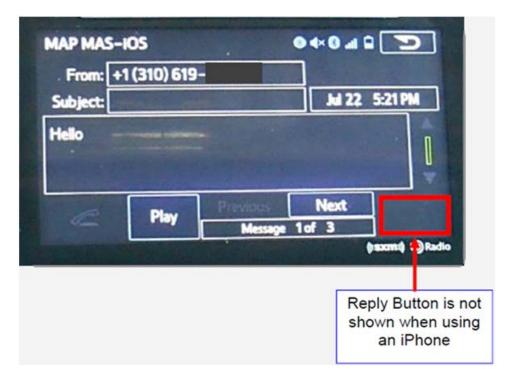
CONDITION #2: Unable to reply to received text messages from the head unit when using an iPhone. CAUSE:

The MAP (Mail Access Profile) does not always allow the user to read and reply (both) to text message content from the smartphone connected to the head unit. Function of MAP profile varies by phone manufacturer. The iPhone provides the MAP (Text Message) feature via Bluetooth. As per Apple specifications, the iPhone's MAP does not support the reply function, only read is supported.

Inform the customer when their iPhone is paired to the head unit, the head unit will be able to display and read aloud the incoming text messages. However, the "Reply" message function will not be available.

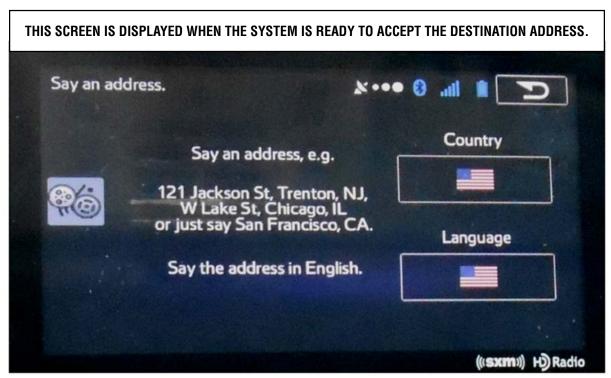
CONDITION #3: Unable to set up the "Destination Address" using voice command.

Voice commands are not spoken with the correct pause, timing or cadence between "House Number", "Street Name", "City Name" and "State" which the head unit can understand.

Say the Destination Address with the correct pause, timing or cadence as shown in the example. Below are examples of incorrect and correct commands:

Incorrect command: 121[pause] Jackson [pause] Street [pause] Trenton [pause] NJ

Correct command: 121JacksonStreetTrentonNJ

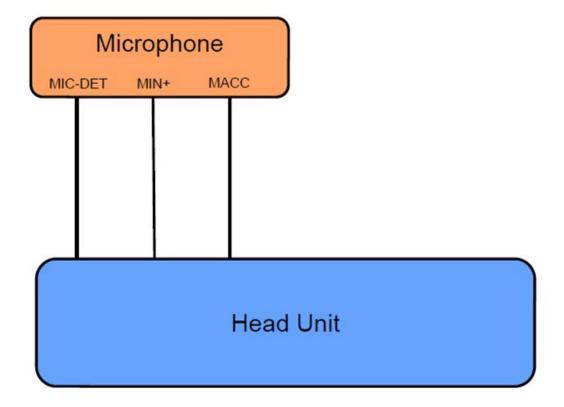
CONDITION: #5: A "Phone" button is not displayed on the HOME screen.

- Microphone is not properly connected to the head unit
- Microphone detection wiring (MIC DET) is open
- Microphone unit is defective

- Confirm the microphone wiring is securely connected to the head unit.
- Confirm there is not an open circuit or short in the Microphone detection (MIC DET) wiring.
- After the wiring has been confirmed to be OK, replace the microphone if necessary.

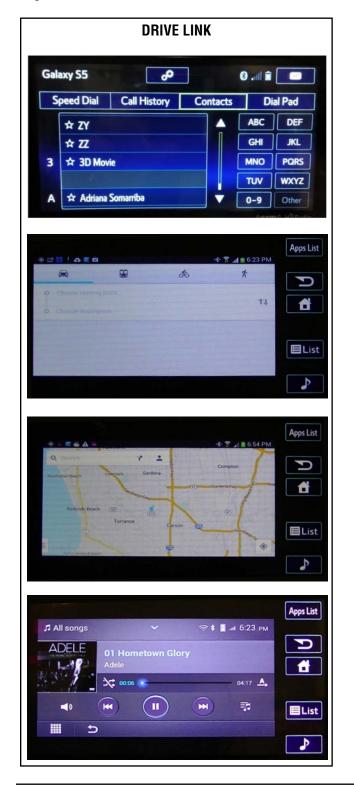
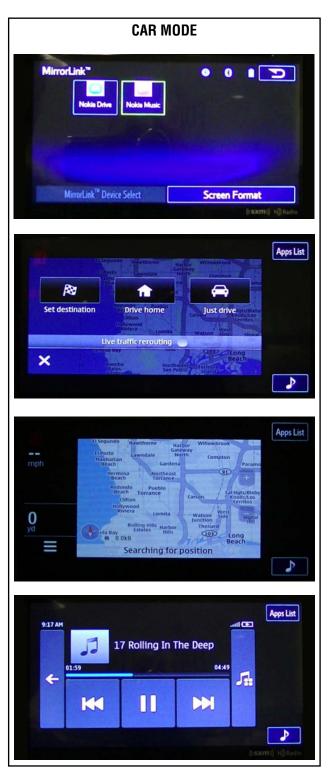
CONDITION #6: MirrorLink screen does not look the same when using "Drive Link" and "Car" mode.

Drive Link and Car mode display screen information on the head unit differently.

Explain to the customer, Drive Link and Car modes will display information differently when accessing the MirrorLink feature of the head unit. Examples of each are shown in the screen shot photos below.

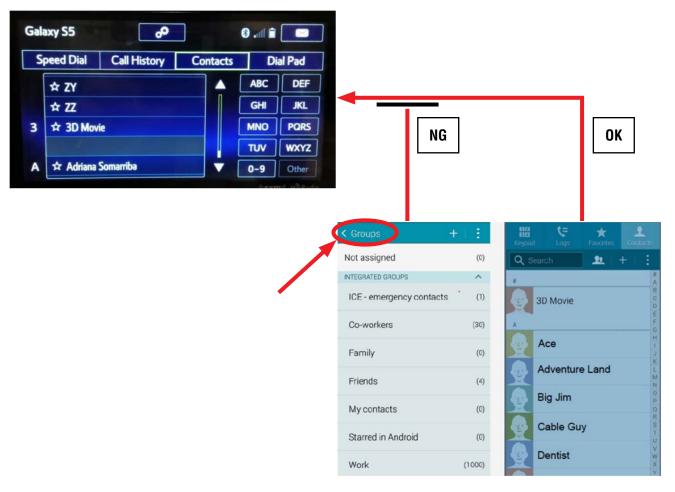
CONDITION #7: Individual contacts will transfer to the head unit from the smartphone, but group folders will not.

Although the head unit can retrieve individual contacts, it does not have the capability to retrieve group folders from the smartphone.

Explain to the customer, the head unit does not support the transfer of group folders from their smartphone.

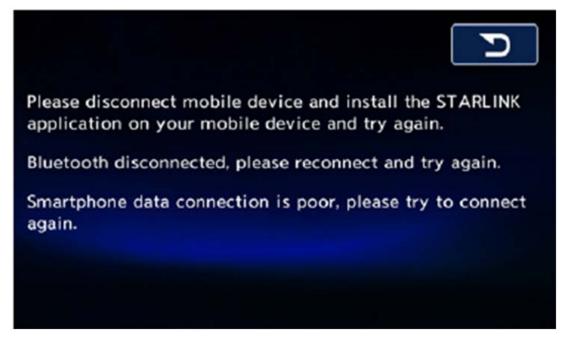
CONDITION #8: When selecting the STARLINK function on the head unit, an error message appears on the screen as shown below.

- STARLINK application on the Smartphone was not loaded and/or launched on the Smartphone prior to selecting the STARLINK function on the head unit. Therefore, Smartphone cannot communicate with STARLINK Server.
- Smartphone has not been paired with the head unit for Bluetooth connection

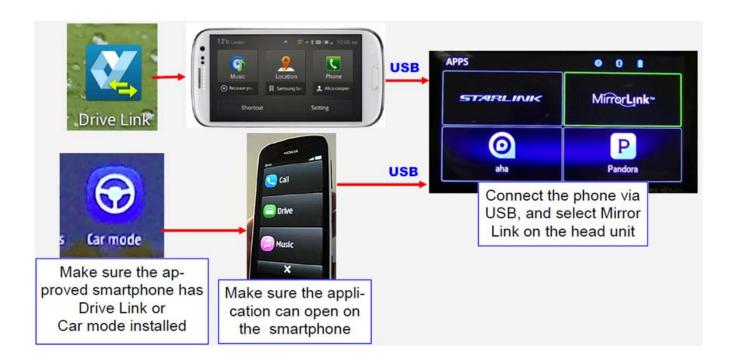
CONDITION #9: MirrorLink does not work with my Samsung or Nokia Smartphone.

- The Smartphone is not compatible with MirrorLink.
- The Drive Link application is not installed on the approved Samsung Smartphone.
- The Car mode application is not installed on the approved Nokia Smartphone.
- The application is not launched or open on the Smartphone.
- The Smartphone is not connected to the head unit with a USB interconnect cable.

- Make sure the Smartphone is compatible with MirrorLink (see Owner Manual Pg. 141.)
- Make sure the "Drive Link" application is installed on the approved Samsung Smartphone (See Owner Manual Pg. 141).
- Make sure the "Car mode" application is installed on the approved Nokia Smartphone (See Owner Manual Pg. 141).
- Once applicability has been confirmed and the application properly installed on the Smartphone, follow the steps below:
 - 1. Open/Launch the application on the Smartphone.
 - 2. Connect the Smartphone to the vehicle with a USB interconnect cable.
 - 3. Press the "APPS" button on the head unit.
 - 4. Select MirrorLink on the head unit.

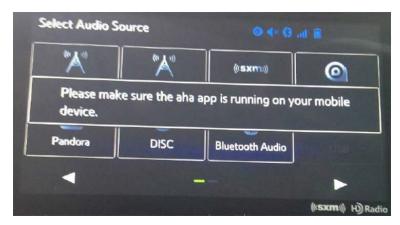
aha Message

CONDITION #10: When selecting aha or Pandora on the head unit with a Smartphone (iPhone or Android) connected, the head unit displays a message informing the user to check the app on their Smartphone (see below).

- Pandora or aha App is not installed on the Smartphone.
- Pandora or aha App is not launched on the Smartphone.
- The iPhone is not connected to the system to the head unit with a USB Cable or in the case of an Android Smartphone, the Smartphone is not paired to the head unit using Bluetooth or launched.

- Download the Pandora or aha app to the Smartphone.
- Launch the Pandora or aha app on the Smartphone.
- Connect the iPhone to the head unit using a USB cable.
- Pair the Android phone to head unit using Bluetooth.
- Select Pandora or aha on the head unit from Audio Source

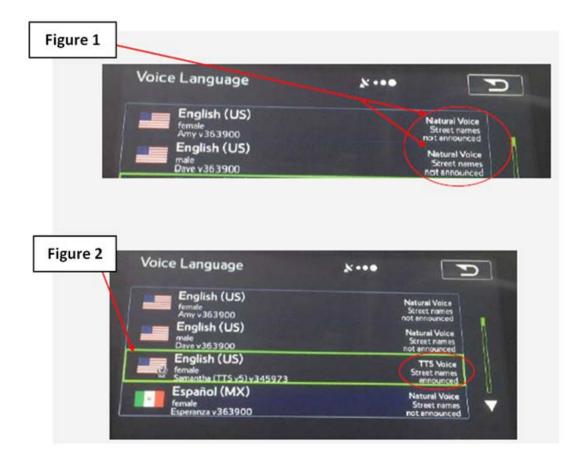
CONDITION #12: When using the voice command to operate navigation system functions, the following message is displayed: "This feature cannot be used with the selected guidance voice profile".

"Natural Voice" (Figure 1) is selected from the Voice Language menu when "Text To Speech" (TTS) is required (Figure 2) for proper voice command operation.

- Follow the steps below to change from Natural Voice to TTS:
 - 1. Select "Home".
 - 2. Select "Settings".
 - 3. Select "General".
 - 4. Select "Language".
 - 5. Select "English (US) TTS Voice".

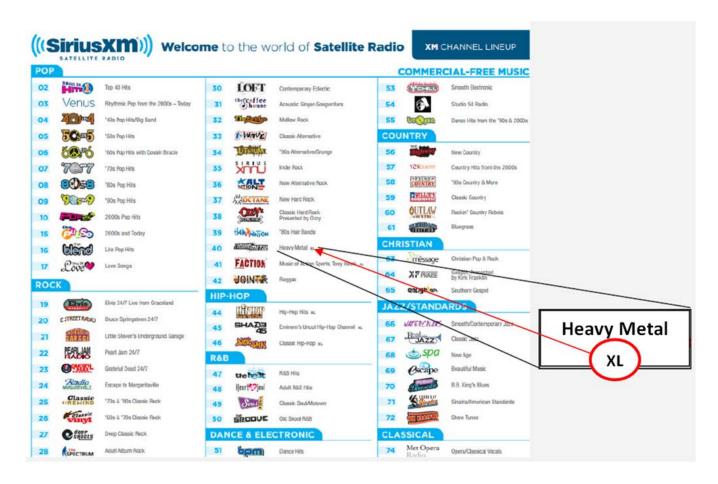
CONDITION #13: The Sirius XM channel reverts back to channel 1 (Preview channel) when the vehicle is started (or restarted).

It is likely the customer was listening to an "Explicit" channel prior to turning the vehicle off.

Find out if the customer was listening to an "Explicit" channel prior to turning the vehicle off. If they were, explain that the head unit software is designed to revert back to channel 1 (preview channel) when restarting to avoid offending new occupants who may have not been in the vehicle previously (e.g. children). A copy of the Sirius XM channel line-up is shown below. "Explicit" channels are identified in the line-up with a "XL" designation.

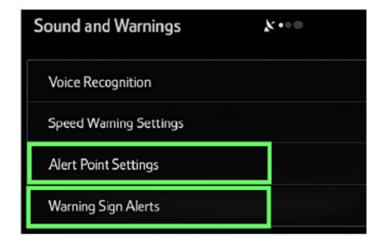
CONDITION #14: A chime is heard while driving.

"Alert Point Warnings" or "Warning Sign Alerts" features are enabled under Sound and Warnings menu.

- If the chime is unnecessary when approaching alert points, disable (uncheck) "Alert Point Warnings" or "Warning Sign Alerts" settings by following the steps below:
 - 1. Select "Menu" on Map screen.
 - 2. Select "More".
 - 3. Select "Settings".
 - 4. Select "Sound and Warnings".

- 5. Select "Alert Point Settings" or "Warning Sign Alerts" (see picture below).
- 6. Disable (uncheck) the settings (press the check mark to "toggle" on / off).

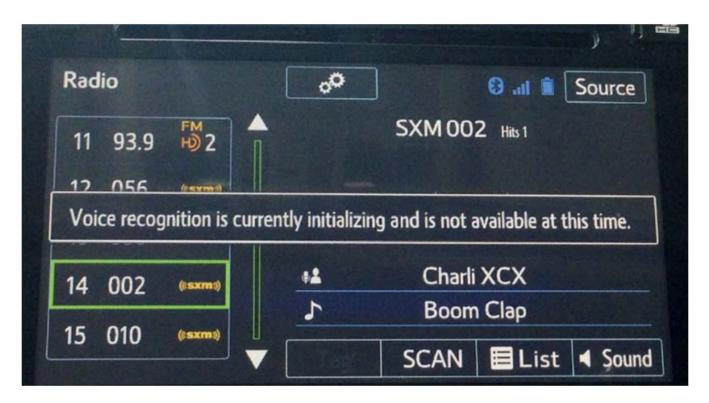
CONDITION #15: The message "Voice recognition is currently initializing and is not available at this time" appears on the screen.

When the head unit is turned on, the system scans XM stations along with every song (digital file) on the currently loaded CD, connected USB device and / or Bluetooth Audio player. It also scans the phone contacts stored on all Bluetooth-connected Smartphones. The system then creates voice tags for all the XM station names, artists, songs, albums, playlists, podcasts, genres, and contacts. During this process, the head unit will also display "Voice Recognition is currently initializing and is not available at this time" (see picture below).

Wait a few minutes then try using the Voice Recognition System again. Once the system has had enough time to complete the procedures described above, normal operation should resume.

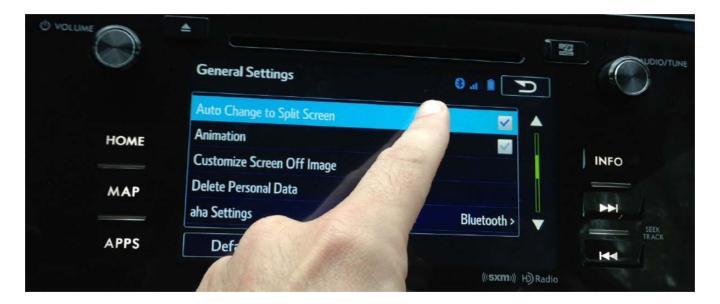
CONDITION #16: After 30 seconds of not pressing any buttons, the screen automatically displays a split screen view

The setting to automatically change to split screen has been turned on.

- Follow the procedure below to turn off the "Auto Change to Split Screen" setting:
 - 1. Select "Home"
 - 2. Select "Settings"
 - 3. Select "General"
 - 4. Scroll down to "Auto Change to Split Screen" and uncheck the setting.

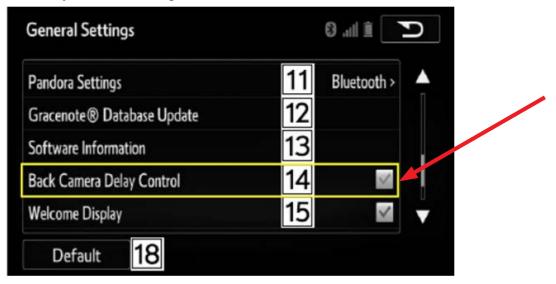
CONDITION #17: Back-up camera image remains displayed after shifting out of Reverse

"Back Camera Delay Control" setting is set to "ON"

When set to "ON", the back-up camera image will remain displayed for about 7 seconds after moving the shifter out of Reverse. The image will turn off when shifting into Park or when vehicle speed exceeds 5 mph.

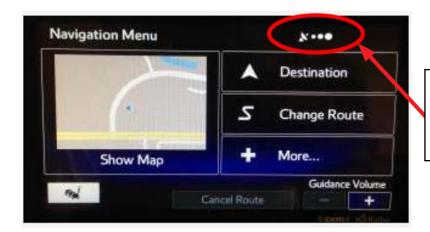
CONDITION #19: Unable to Locate the GPS Information Screen

The detailed GPS Information screen is only available if the GPS signal becomes weak.

The GPS Signal strength indicator is always available for reference in the upper right of the "Navigation Menu" screen.

On the "Navigation Menu" screen, the GPS signal strength indicator is always available at the top right of the screen as shown below. In addition, if the GPS signal strength becomes weak, a Satellite icon will show when the MAP screen is displayed. If this Satellite icon (also a soft key) is pressed, the GPS information screen will be displayed which indicates how many satellites are currently being received along with the accuracy of the GPS signal.

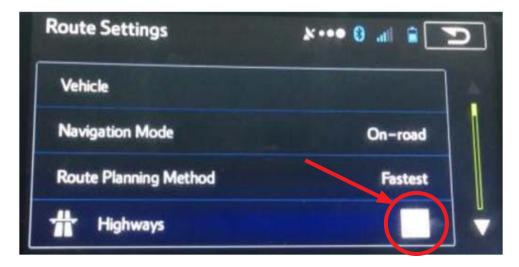
CONDITION #20: The Navigation system often routes the user off the highway, and onto rough surface (dirt / gravel) roads.

In the Route Settings menu, the "Highways" selection box is unchecked.

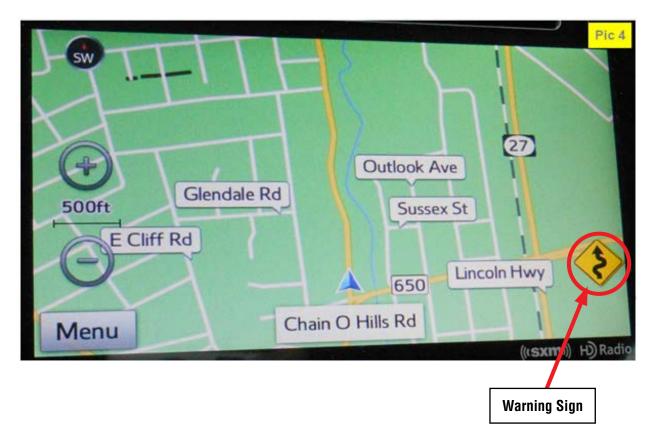
CONDITION #21: When the Speed Limit is displayed, "Alert Signs" are not displayed, even when "Warning Sign Alerts" and Alert Point Settings" are enabled.

Display of the Speed Limit takes priority over Warning Sign Alerts and Alert Point Warnings. If the Speed Limit is being displayed as shown in Pic 1 below, the other warnings will not be displayed.

- 1. If the Speed Limit is not being displayed on screen, other warning and alert signs will be displayed as shown below in Pic 4 provided those settings are enabled.
- 2. If the Speed Limit Warning is disabled, only the warning and alert signs will be displayed (provided those settings are enabled).

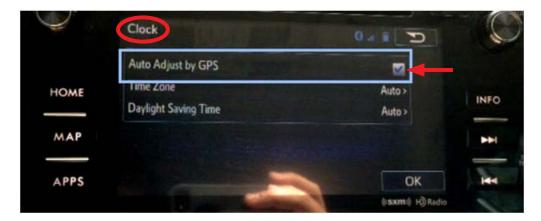
CONDITION #23: The clock display on HVAC panel is incorrect even when "Auto Adjust by GPS" is selected on the Clock settings menu.

The correct time is 4:59 pm but HVAC display shows 8:59 pm.

When a map SD card is removed from the AVN unit or the map SD card cannot be read properly by the AVN unit, the time displayed on the HVAC panel will automatically default to Greenwich Mean Time (GMT). In this case, the GMT is 4 hours "ahead" of local time.

1. If the user wants to operate the AVN unit without the map SD card installed and still have the correct time shown on the HVAC panel, access the Clock settings menu, uncheck "Auto Adjust GPS" then manually reset the correct time using "+" and "-" buttons to the left of the clock display as shown below.

2. If the map SD card is installed in the AVN unit, but the maps and / or time is not being displayed correctly, it may be due to a defective map SD card or possibly a faulty AVN unit.

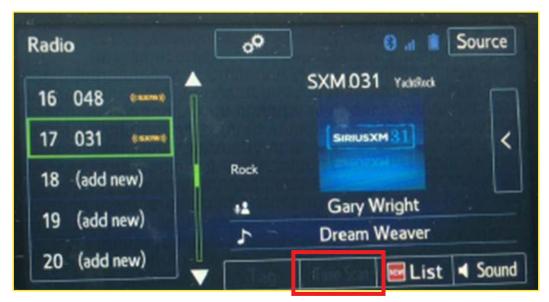
CONDITION #25: The "Tune Scan" feature is unavailable (2016 MY vehicles equipped with Gen 2.1 Navigation / Display Audio system).

YES: Pressing the button will activate "Tune Scan"

NO: Check to see if the user has any SXM presets setup as "Smart Favorites" (See Owner's Manual pg. 75 for more about "Smart Favorites")

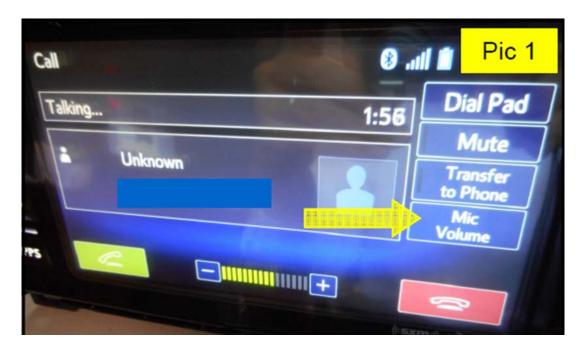
CONDITION #26: Bluetooth hands-free outgoing voice quality is poor. Call recipient cannot understand the caller in the car clearly.

1. Access "Mic Volume" function by touching the soft key during a hands-free call (**Pic1**).

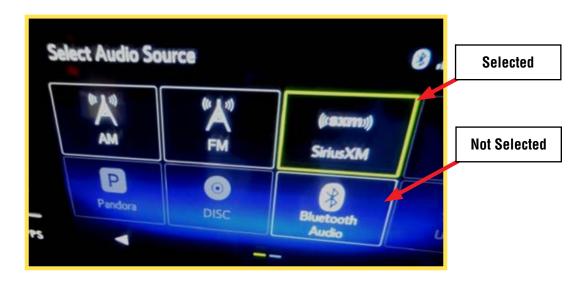
CONDITION #27: Navigation voice guidance cannot be heard from the vehicle speakers when the destination was requested by Siri (iPhone App) (2016 MY vehicles equipped with Gen 2.1 Navigation / Display Audio system)

Bluetooth Audio is not selected as an Audio Source.

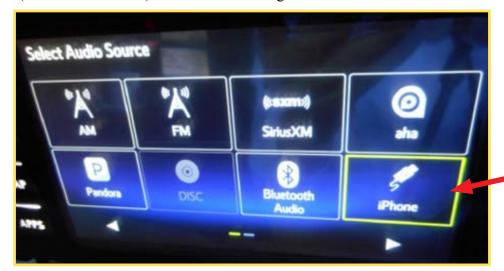
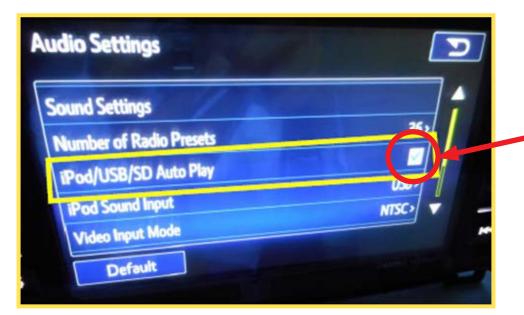
CONDITION #28: When connecting an iPhone to the USB port to charge it, the Audio Source automatically switches to iPhone.

If the unit automatically "defaults" to iPhone mode, the "iPod/USB/SD AutoPlay" setting is selected (activated / checked) on the Audio Settings screen.

If the user does not want the unit to switch to an "iPhone" mode automatically when an iPhone is connected to the USB, disable the "iPod/USB/SD Auto Play" setting by following the steps below:

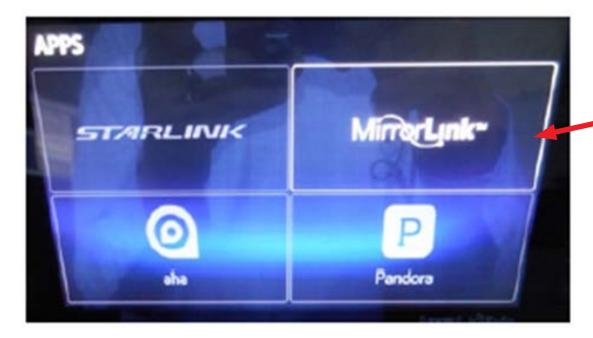
CONDITION #29: The "MirrorLink" button in the APPS screen is not active (grayed out).

- (1) Once MirrorLink compatibility with the phone has been confirmed, install MirrorLink-enabled app.
- (2) After installation is complete, connect the phone to the USB port.
- (3) Wait until the MirrorLink button becomes active on the APPS screen.

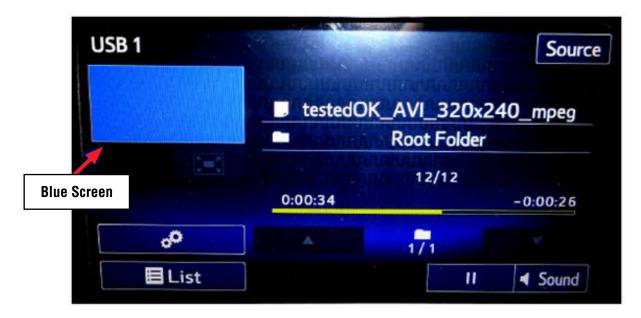
REMINDER: The parking brake must be engaged in order to watch videos. If not, the unit will display the blue screen as shown below but audio will be heard normally.

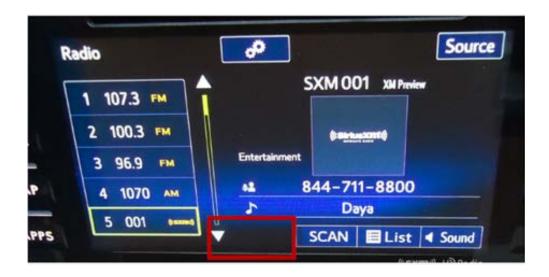
CONDITION #31: The "Tag" button cannot be selected on the Sirius XM Screen

Canadian specification: NO Tag button

Determine if the vehicle is Canadian or U.S. specification.

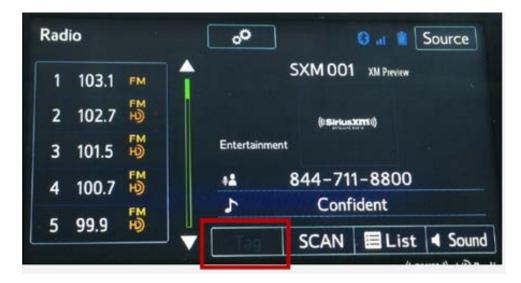
U.S specification: Tag button is outlined and either selectable or grayed out (as shown).

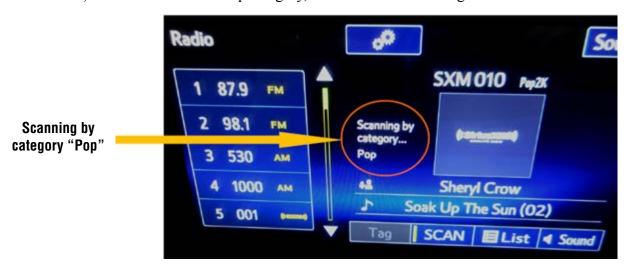
CONDITION #32: Cannot scan or seek through all SXM channels using the Seek, Scan and / or Steering Wheel buttons (2016 MY vehicles equipped with Gen 2.1 Navigation / Display Audio system)

The unit will only scan or seek through the category being listened to when it is in the SXM mode. EXAMPLE: If you are listening to CH2, which is under a "Pop" category, and press the scan button, it will only scan channels (CH3, 4, 5, 6, 7, 8, 9, 10, 13, 14, 15, 16, 17, 18, 158, 300, 301, 302 and 2) which are under the Pop category, not all channels or categories.
