**PRODUCT CAMPAIGN BULLETIN**

**APPLICABILITY:** 2015-2016 MY Forester 2.0XT  
 2015-2016 MY WRX 2.0 DIT  
**SUBJECT:** Turbocharger Air Intake Duct

**NUMBER:** WTA-62  
**DATE:** April 4, 2016  
**NHTSA ID:** 16V162

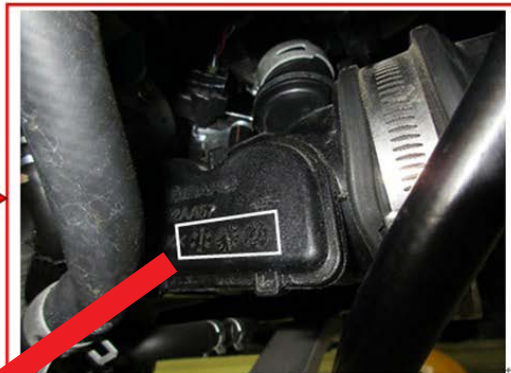
- Inspect the lot number (date) of the turbocharger air intake duct as shown below.

**IMPORTANT:** Only turbocharger air intake ducts with a lot number (date) of **APRIL** (Month 4), 2015 require replacement. If the duct requires replacement based upon the date code, proceed to Replacement Procedure section. If the lot number (date) is confirmed to be **OTHER THAN APRIL, 2015** (Month 4), the turbocharger air intake duct does **NOT** need to be replaced. Continue on to undercover reinstallation.

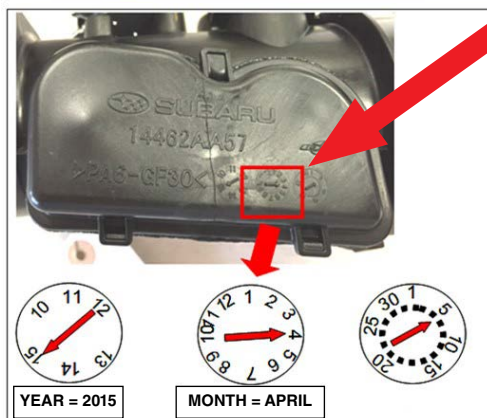
**NOTE:** Do not confuse this lot number (date) with the lot number (date) visible from the front of the vehicle.
