## SERVICE BULLETIN

**APPLICABILITY:** 2013-14MY Legacy and Outback Models with 2.5L FB Engines  
 2011-14MY Forester Models with 2.5L FB Engines  
 2015 MY Forester (Manual Transmissions Only) with 2.5L FB Engines  
 2012-13 MY Impreza and XV Crosstrek Models with 2.0 FB Engines  
 2014-15 MY Impreza and XV Crosstrek Models (Manual Transmissions Only) with 2.0 FB Engines

**NUMBER:** 02-157-14R  
**DATE:** 08/28/14  
**REVISED:** 04/28/16

**SUBJECT:** Engine Oil Consumption

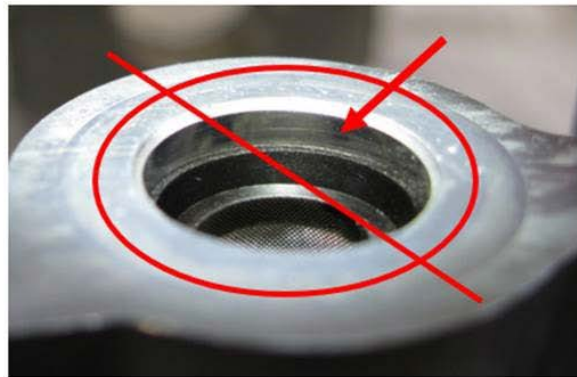
**NG-** Filter Screen installed too deep into the camshaft carrier bore.

- **IMPORTANT:** **The one-time use** AVCS filter screens in the cam carriers are available separately (p.n. 14451AA050). **NOTE:** **Although the filter screens are not directional, they must be installed flush with the machined surface of the cam carrier as shown in the OK photo below. The NG photo shows the screen installed too deep into the camshaft carrier.** Engines with AVCS on both intake and exhaust will have 2 filters in each carrier as opposed to just one (intake only AVCS).
