SERVICE INFORMATION

APPLICABILITY: All Models with STARLINK Telematics System **NUMBER:** 15-195-16
SUBJECT: Servicing and Claim Submission Requirements for STARLINK Diagnosis and Repair Involving the Data Communication Module (DCM) **DATE:** 04/28/16

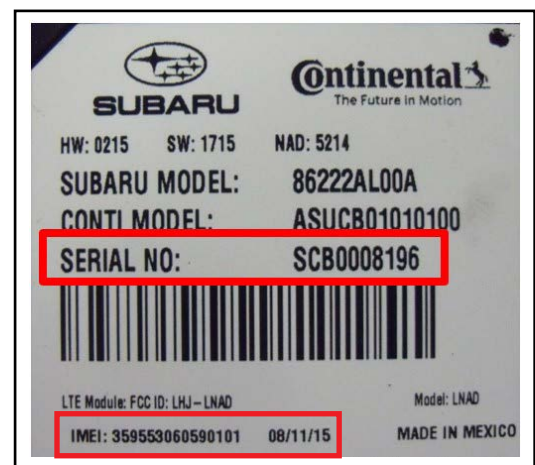
- Collect at least 10 seconds of normal sampling data from the DCM.
- Remove the DCM and note:
 - o the DCM Serial Number and
 - o the IMEI Number on the part label.

IMPORTANT: Effective Immediately, all claims for a DCM replacement MUST include the 10 digit DCM Serial Number of the installed (new) DCM. This number is found on the DCM label (see photo above) and MUST be entered in the Misc. Detail Field for claim submission. The IMEI number should be noted on the repair order, but is not required for claim submission.
