## SERVICE PROGRAM BULLETIN

**APPLICABILITY:** 2015 MY WRX 2.0L DIT Models  
 2014-2015 MY Forester 2.0L DIT Models  
**SUBJECT:** Engine Control Module (ECM)  
 Reprogramming

**NUMBER:** WQW-58R  
**DATE:** February 10, 2016  
**REVISED:** April 15, 2016

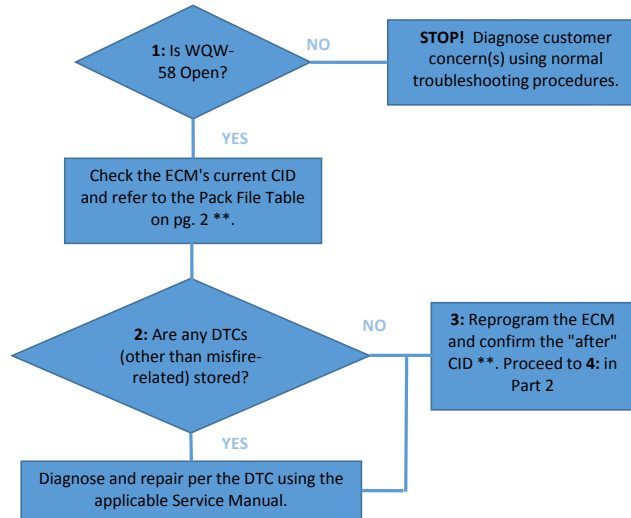
## PART 1:

APPLICABILITY and  
REPROGRAMMING

**\*\*IMPORTANT:** If ECM  
or engine is modified,  
refer to Modified  
Vehicles section of this  
bulletin.

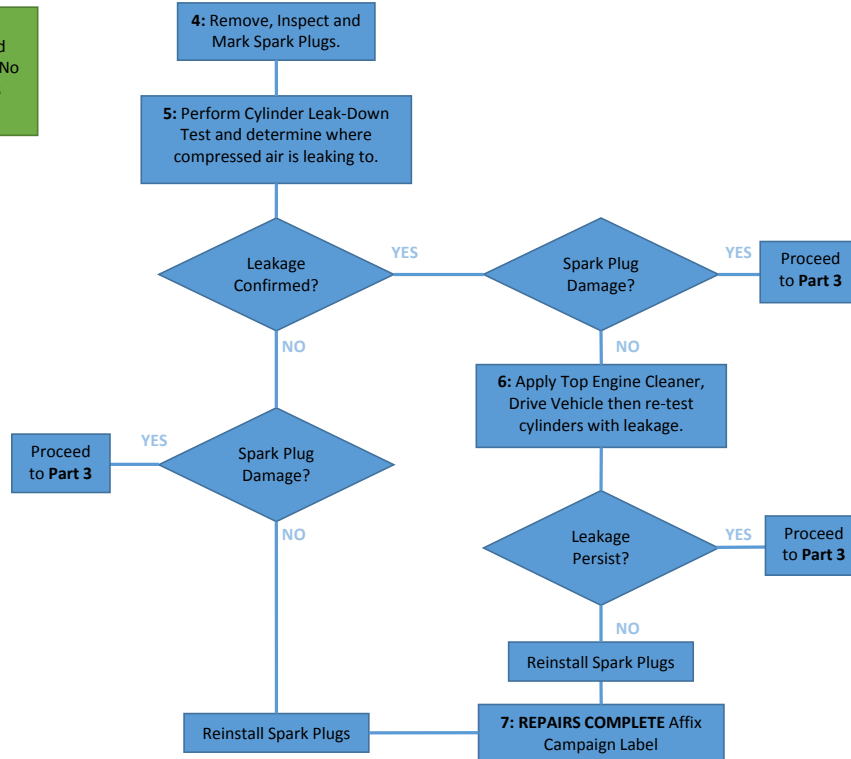
## PART 2:

DIAGNOSIS and  
SIMPLE REPAIR (No  
engine repairs  
required).

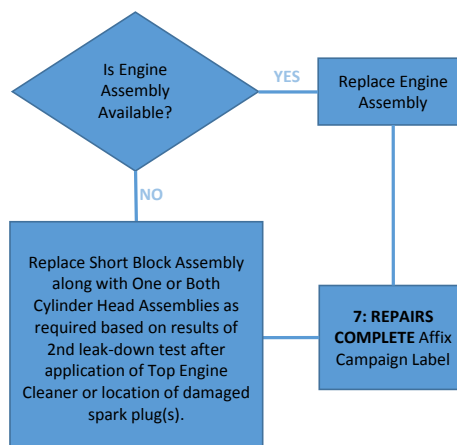
## PART 3:

ADDITIONAL  
DIAGNOSIS AND  
ENGINE REPAIR  
PROCEDURE

**IMPORTANT:** All  
conditions must be  
confirmed per the  
information supplied later  
in this bulletin. Refer to  
applicable bulletin section  
for full details.  
Inappropriately replaced  
engine claims will be  
debited. If unsure of your  
findings, contact your FSE  
or Techline to review.

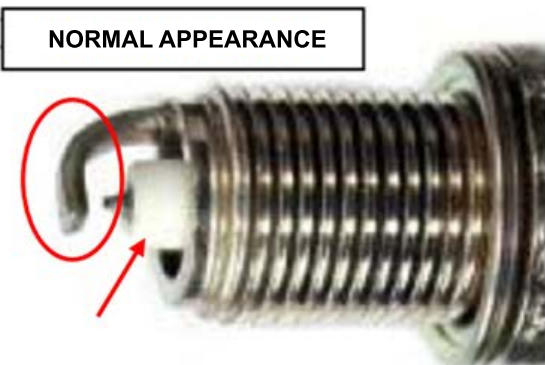
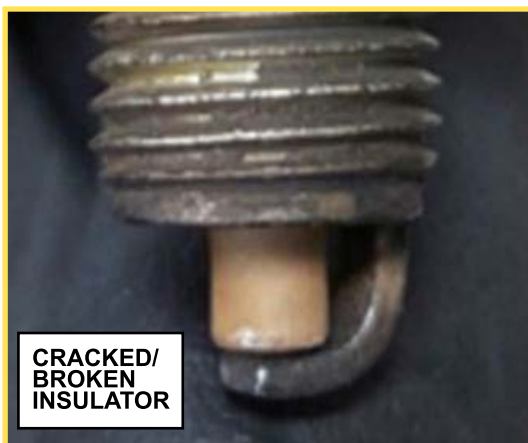
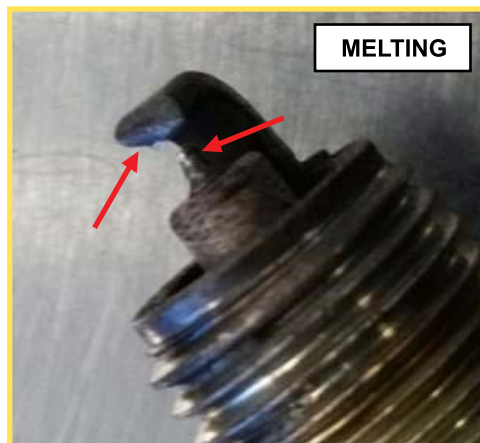
**Step 4:** Remove and inspect the spark plugs closely for any damage, erosion or melting. Inspect, rotate, turn upside-down and shake each spark plug to check for a cracked or loose porcelain insulator around the center electrode. Take note which cylinder(s) have spark plugs with verified damage and mark each plug, damaged or not, with the corresponding cylinder number.

**NOTE:** Any damage to the spark plug porcelain outside of the cylinder head is not a result of this condition.

- If the inspections performed in **Step 4** above revealed spark plug damage, the engine assembly must be replaced (refer to Part 3 of Flow Chart) following the procedure in the applicable Service Manual.
