SERVICE PROGRAM BULLETIN

APPLICABILITY: 2015 MY Legacy & Outback
SUBJECT: Service Campaign – Electronic Parking Brake Reprogramming

NUMBER: WTB-63
DATE: April 28, 2016

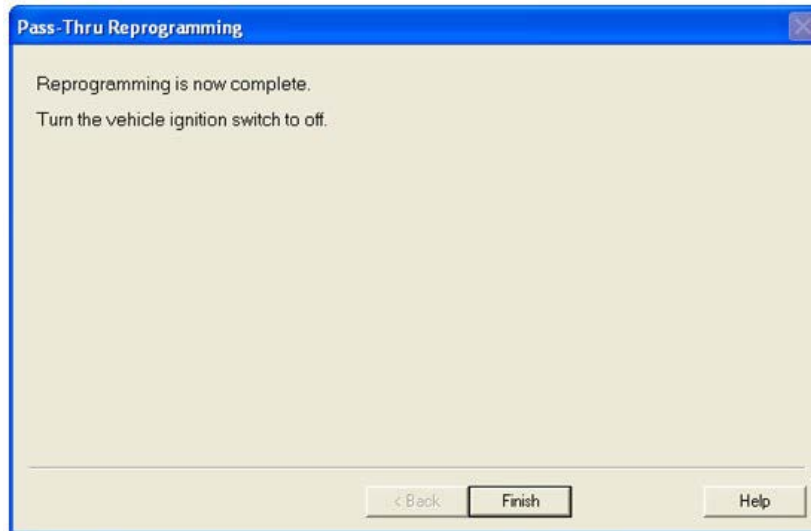
- Reprogram the VDCCM using the normal FlashWrite procedure. When

completed successfully, the screen shot shown below will be displayed.

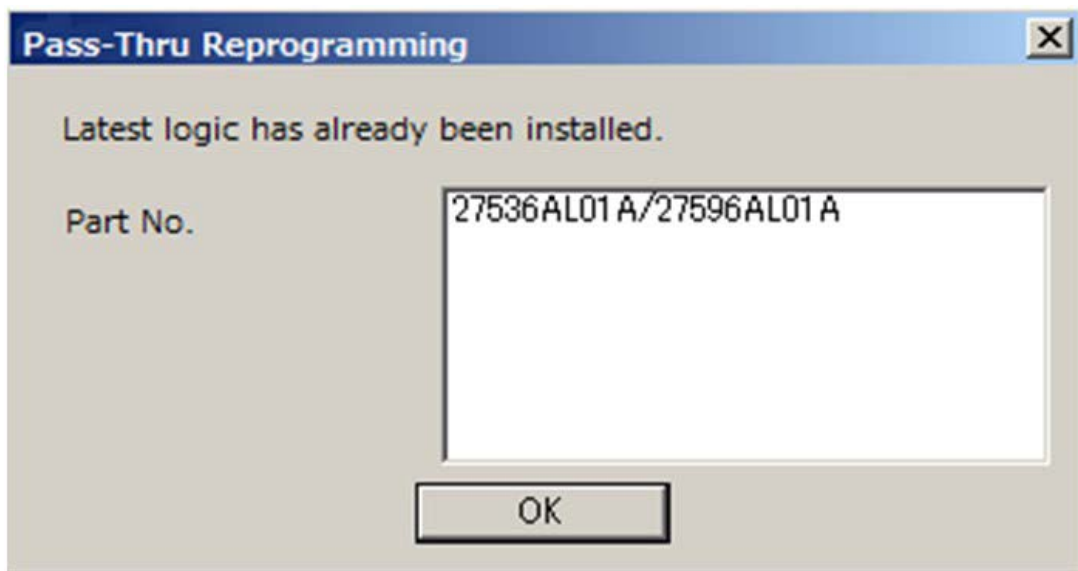
- If the update is not completed as shown in the previous screen shot, perform the reprogramming again and check to see if the “Latest logic has already been installed” screen shot below is displayed. If so, the procedure is complete. If

not, perform the reprogramming procedure again.
