Radio Controls Inoperative At Cold Temperatures

YEAR(S)	MODEL(S)	ADDITIONAL INFORMATION
2016	Highlander

TOYOTA T-SB-0034-16 May 11, 2016 Page 2 of 3

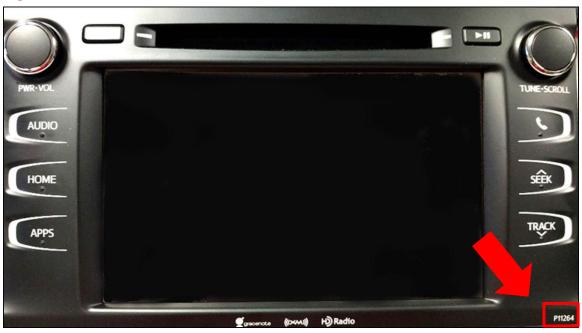
Figure 1.

- YES Go to step 2.
- **NO** This bulletin does NOT apply. Continue diagnosis using the applicable Repair Manual.
- 2. Confirm the audio system by checking the Faceplate ID printed on the bottom right corner of the head unit.

Does the Faceplate ID read P11264?
