Entune Audio Head Unit Software Update (Panasonic)

Service Category Audio/Visual/Telematics

The information contained in this bulletin supersedes SB No. T-SB-0160-14.

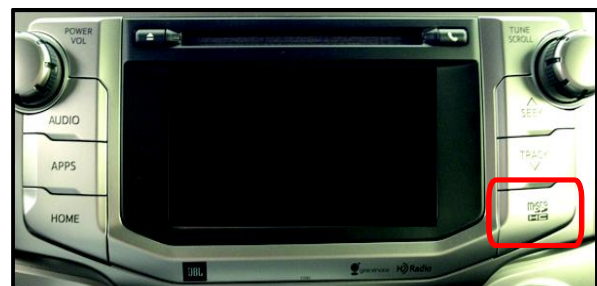
Figure 17.

If update fails and the error message “New software is not compatible with the system.” displays, cycle the ignition OFF, remove the Map Micro SD Card from the head unit, and repeat steps 2 – 11.

Software update error is more likely to occur in areas with more traffic information.

Once update is complete, reinsert the Map Micro SD card into the head unit, cycle the ignition OFF, and proceed to step 13.
