**TECHNICAL INSTRUCTIONS**  
**FOR**  
**CUSTOMER SATISFACTION CAMPAIGN CLA**  
**ENGINE CONTROL MODULE (ECM) REFLASH**  
**CERTAIN 2013 MODEL YEAR GS350**

**UPDATED July 26, 2016**

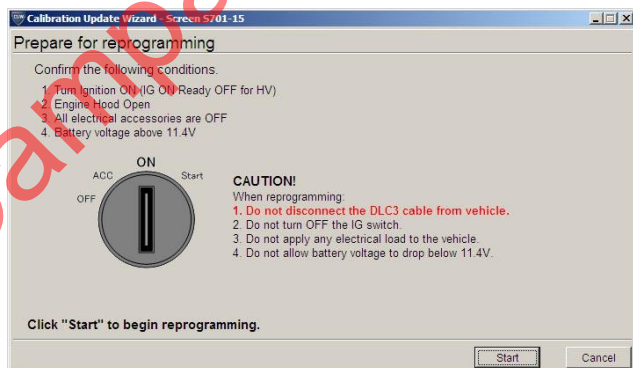
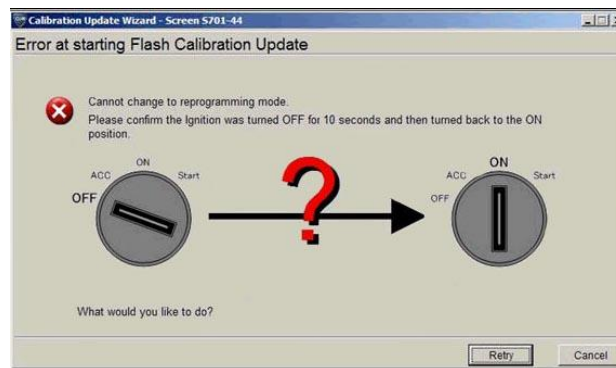
### PAY CLOSE ATTENTION DURING THIS STEP OF THE REFLASH PROCESS

After turning IG ON it may be necessary to wait an additional 25-30 seconds before pressing Start on the CUW.

If Start is pressed on the CUW before allowing enough time to elapse, an error may occur and the CUW will request that you retry the process.

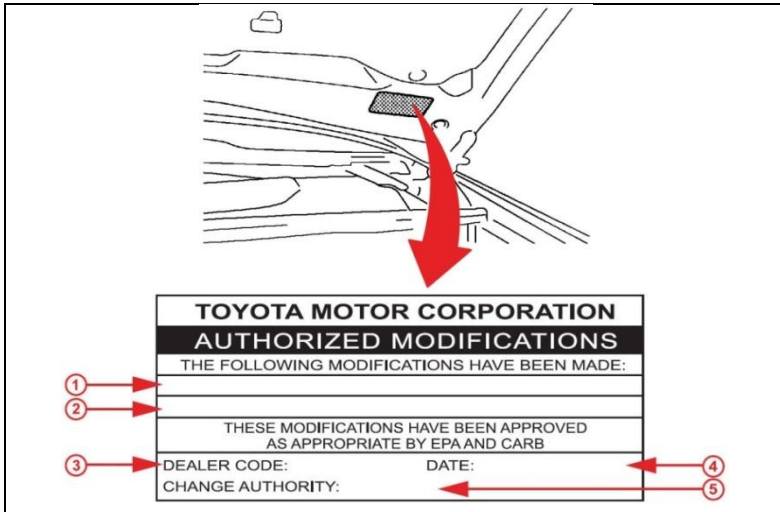
<b>1</b>	Replacement ECM P/N 2WD – 89661-30U51 4WD – 89661-30U61
<b>2</b>	New Calibration ID 2WD – 330S2100 4WD – 330S3100
<b>3</b>	Dealer Code
<b>4</b>	Date Completed
<b>5</b>	Campaign Code (CLA)

**3. ATTACH THE AUTHORIZED VEHICLE MODIFICATION LABEL**

- a) Fill out the label.
- b) Affix the label to the under-side of the hood.
