G12 PHEV - FUEL LINE RATTLE NOISE

G12 PHEV (740xe)	
Produced up to 09/29/2016

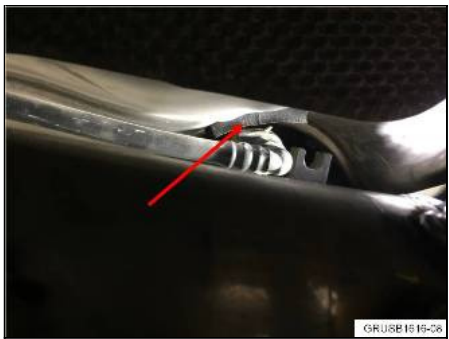
Interference between the fuel line quick connector and the side wall of a fuel tank.

<p>GRUSE1616-06</p>	<ol style="list-style-type: none"> 1. Locate the fuel line's quick disconnect connector. <ul style="list-style-type: none"> • General location of the fuel line quick connector: passenger side, behind the fuel tank wall.
<p>GRUSE1616-07</p>	<ul style="list-style-type: none"> • Specific location of quick connector (circled).

<ol style="list-style-type: none"> 2. Place a piece of the insulation foam between the fuel line connector and the wall of the fuel tank. 3. Duplicate reported conditions and verify effectiveness.
---	--
