EXTERIOR MIRRORS GO TO RANDOM POSITION

This Service Information bulletin supersedes SI B51 29 16 dated September 2016.

F48 (X1)

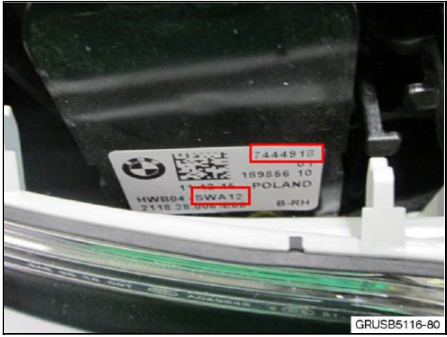
Situation A- Mirror motor electronics module software version. (Only applies to vehicles produced up until March 2016)

Situation A

Situation A - Install new mirror motor electronics modules on the driver's and passenger's side rear view mirror. (Only applies to vehicles produced up until March 2016)

<p>GRUSB5116-80</p>	<ol style="list-style-type: none"> 1. Verify the customer's complaint as described by the situation statement (A). 2. Remove the cover of either the passenger's or driver's side rear view mirror and note the SWA version as shown. 3. If the SWA version is lower than SWA12, replace both mirror electronics modules and reprogram the vehicle with the latest version of ISTA/P. Refer to RA 61 31 ... "Removing and installing or replacing left and/or right mirror electronics". 4. If the SWA version is already SWA12 or higher, do not replace the mirror electronics module. Submit a PuMA case for further assistance.

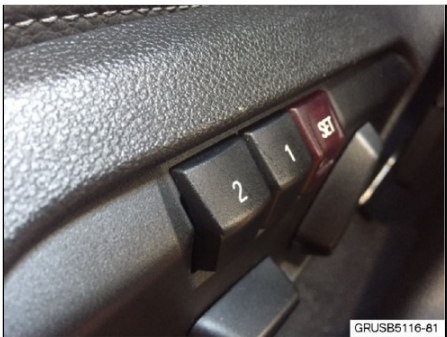
Situation B- Unintentional actuation of seat-mounted memory switch (the switch on this vehicle is mounted in a position where a customer can inadvertently press it when entering or exiting the vehicle), or the Personal Profiles settings have not been set to the customer's preferred mirror and/or seat positions .

Situation B

Situation B – Inform the customer on the operation of the seat/mirror memory buttons, and make the customer aware of the possibility of unintended switch operation.

<p>GRUSB5116-81</p>	<ol style="list-style-type: none"> 1. Verify the customer's complaint and inform the customer of the operation of the seat/mirror memory switches and the possibility of inadvertent operation. 2. Verify that the customer's preferred seat/mirror settings are applied to the correct memory position.
