## SERVICE ACTION: CONVERTIBLE ROOF: TENSIONING STRAP REPLACEMENT

F23 (2 Series Convertible)
----------------------------

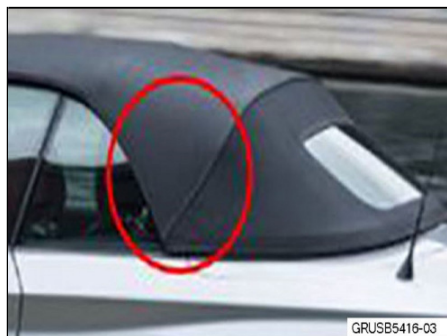
1. **Check the headliner for damage in the C-pillar area on the left and right sides.**

**YES** – Follow procedure in Headliner Repair Attachment for “Replacing the Headliner”.

**NO** - Follow procedure in Headliner Repair Attachment for “Tension Cable Conversion”.

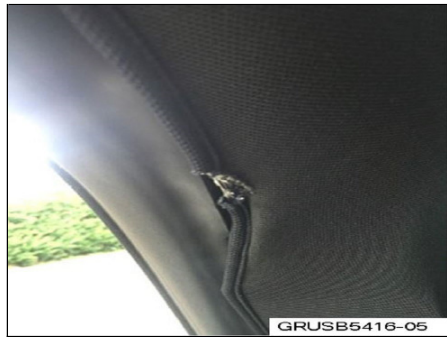
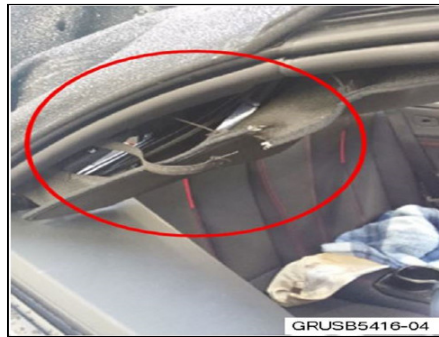
The tensioning strap that is fastened to the headliner could fail during convertible top operation.

Tensioning strap can become jammed or trapped in convertible top mechanism leading to failure.

- **Examples of headliner damage**
