## DME Electrical Wastegate Valve Faults - Adaptation Limit Positions Not Detected

F22 (2 Series Coupe)	F23 (2 Series Convertible)	F30 (3 Series Sedan)	F32 (4 Series Coupe)
F31 (3 Series Sport Wagon)	F33 (4 Series Convertible)	F34 (3 Series Gran Turismo LCI)	F36 (4 Series Gran Coupe)
G12 (7 Series Sedan)

With the B46O, B48M, B48O, and B58M engines produced up to 7/31/2016.

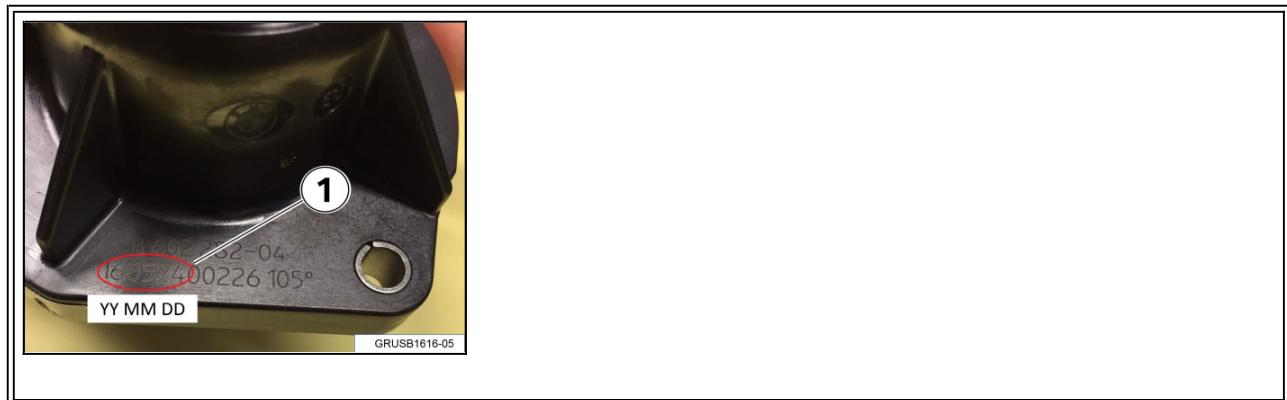
Although the improved vehicle wiring harness has the same part number, it can be identified by the index (1) at the rear of the part number. (2) indicates the last 7 digits of the part number.

Part number	Index number for improved parts
12 51 8 631 656	05 or higher
12 51 8 631 658	05 or higher
12 51 8 631 660	04 or higher
12 51 8 631 662	05 or higher
12 51 8 636 054	07 or higher
12 51 8 636 055	07 or higher
12 51 8 642 919	05 or higher
12 51 8 669 730	02 or higher

1. Perform diagnosis using the latest version of ISTA.
2. Inspect and / or replace the Engine sensor system module 1 vehicle wiring harness (see graphic for part number location).

3. Replace the “Engine sensor system module 1 vehicle wiring harness“. Obtain the required part number from the Electronic Parts Catalogue (EPC).
