Creaking/Cracking Noise from the Upper Roof Area

| R60 (Cooper, Cooper S Countryman) |
| Produced from July 31, 2011 |

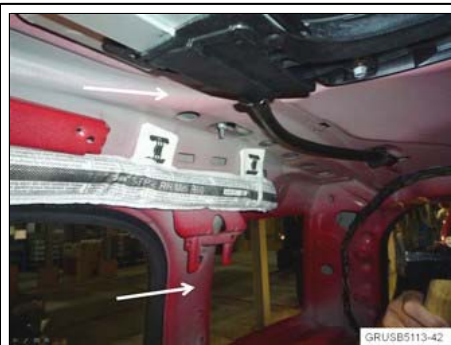
1. Confirm the location of the roof noise being generated at the upper area of the C-pillar, and proceed to the next step.

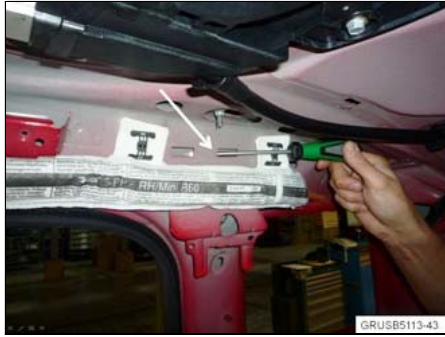
3. Road test the vehicle with a helper, inserting a screwdriver through the roof, and opening and

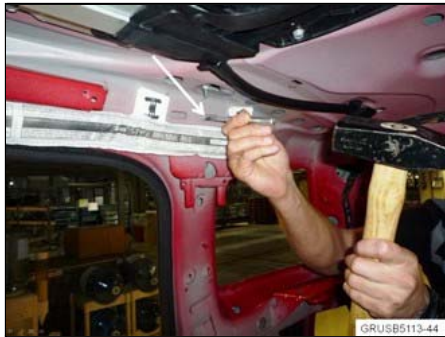
applying varying pressure to the metal roof support as shown. If the noise can be eliminated by applying pressure, proceed to the next step
