SI B11 15 16
Engine

August 2016
Technical Service

B58 ENGINE: OIL LEAK FROM TURBOCHARGER

F30 (3 Series Sedan)	F32 (4 Series Coupe)	F33 (4 Series Convertible)	G12 (7 Series)
With B58M engine

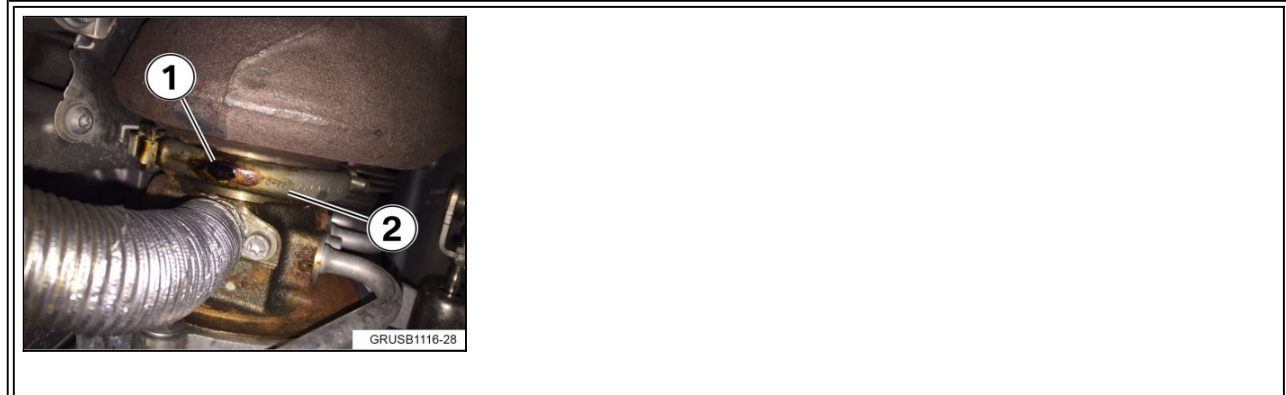
Engine oil (1) can be seen leaking from the bottom of the turbocharger near the band clamp (2).

The turbocharger band clamp is loose.

Tighten the turbocharger band clamp.

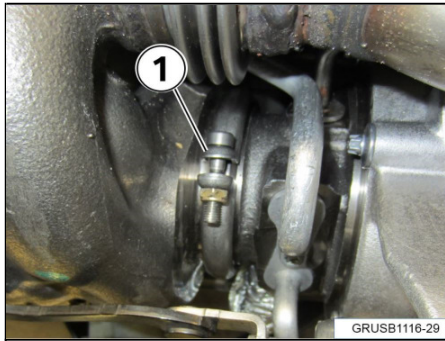
3. Remove the air filter box and locate the band clamp fastener (1).

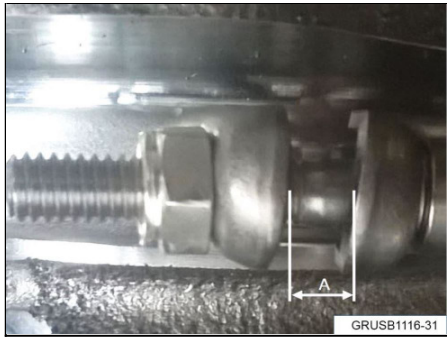
6. When the torque procedure is complete, measure the gap in the band clamp. The gap should **NOT** be less than 0.5 mm.

A = > 0.5 mm

If the clamp gap is less than 0.5 mm then the turbocharger will need replacement.
