PARKING BRAKE DOES NOT WORK

E70 (X5) E71 (X6)	E70 (X5) E71 (X6)
-------------------	-------------------

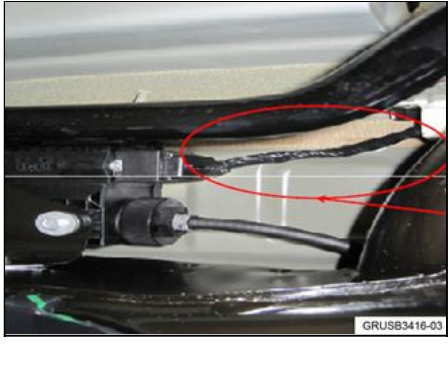
<p>GRUSB3416-03</p>	<ol style="list-style-type: none"> Check the wiring harness for damage in the area shown. Is the harness damaged? YES- go to next step. NO – no additional repair indicated by this bulletin, follow the ISTA test plan. <div style="text-align: center;">
