WATER LEAKING INTO REAR COMPARTMENT

F07 (5 Series Gran Turismo)

F12 (6 Series Convertible)

F13 (6 Series Coupe)

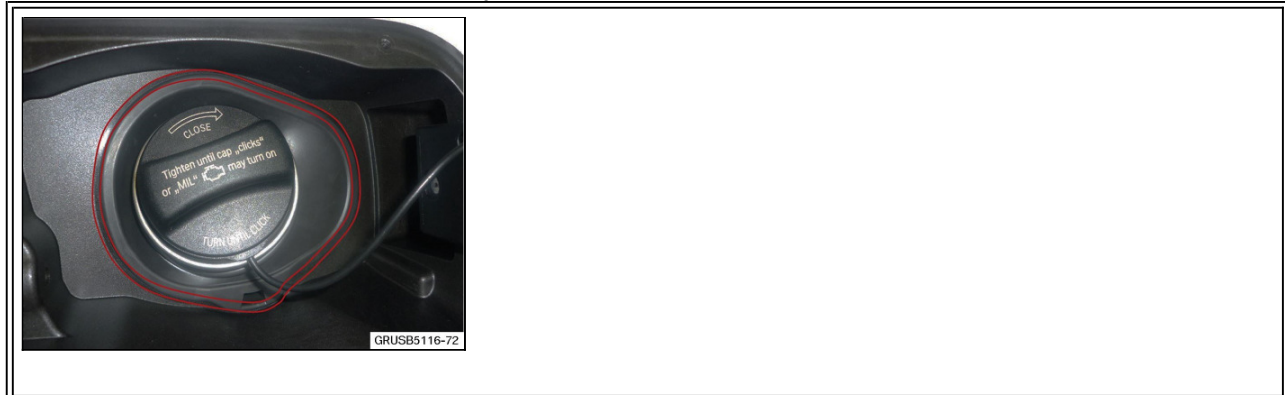
Water is found in rear compartment.

Seal around fuel filler tube (located by red lines) is not effective.

Replace cover pot (bowl).

2. Refer to REP 41 63 003 "Replace Cover Bowl", replace cover bowl.
3. Verify water tightness.
