## CREAKING NOISES FROM DOOR TRIM PANEL

F22 (2 Series Coupe)	F23 (2 Series Convertible)	F30 (3 Series Sedan)	F31 (3 Series Wagon)
F32 (4 Series Coupe)	F33 (4 Series Convertible)	F34 (3-Series GT)	F36 (4 Series Gran Coupe)
F80 (M3 Sedan)	F82 (M4 Coupe)	F83 (M4 Convertible)	F87 (M2 Coupe))

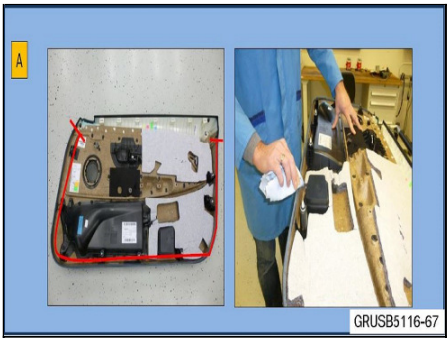
Creaking noise is heard from door trim panel while driving on rough roads.

Door trim panel is contacting the inner door panel.

Apply anti-creaking (fabric) tape to the contact surfaces.

<ol style="list-style-type: none"> <li>1. Remove the door trim panel on the affected side using ISTA Repair Instructions "51 41 000 Removing and installing left or right front door trim panel"</li> <li>2. Using a lint free cloth and cleaning agent (Such as BMW Part # 83 19 0 417 324) clean all contact surfaces between door panel and body.</li> </ol>
	<ol style="list-style-type: none"> <li>3. Apply anti-creaking (fabric) tape (83 19 2 289 397) to the return edge of the door trim panel.</li> <li>4. Inspect the panel for any additional contact areas, repeat steps above as needed.</li> </ol>
