## Service Action: Repair Roof Side Frame Paint

This Service Information bulletin supersedes SI B51 35 15 **dated March 2016**.

F82 (M4 Coupe)
----------------

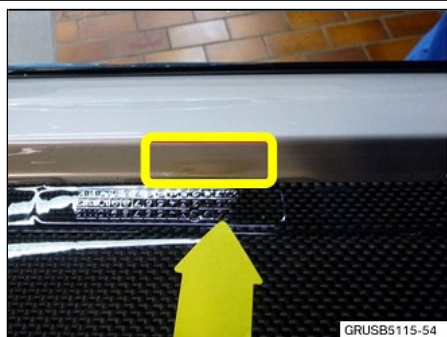
Paint may be blistered / damaged in the area on the left side roof side frame

Paint on the left roof side frame may be damaged due to exposure to high heat during production.

2. Locate the area by the carbon fiber roof panel. The area to be inspected is on the left side approximately 65 to 69 cm from the front edge.
3. The area that may be affected is approximately 3-5 cm in size and is located on the inside edge.

4. If no damage is found with the paint, no further action is required.
5. Reassemble the removed parts to the vehicle.
