REWORKING THE PVC SEAM SEAL ON THE RIGHT REAR WHEEL ARCH

F36 (4 Series Gran Coupe)

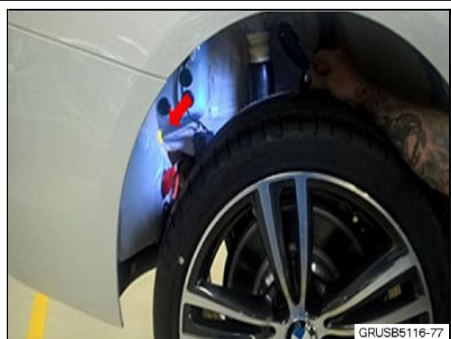
PVC Seam Sealer on the right rear inner wheel arch may not have been properly applied.

The affected area is marked in the image below (red arrow). Both sides of the PVC seam must be sealed.

1. Remove the rear right wheel arch trim panel as described in the repair instructions **REP 51 71 041**.

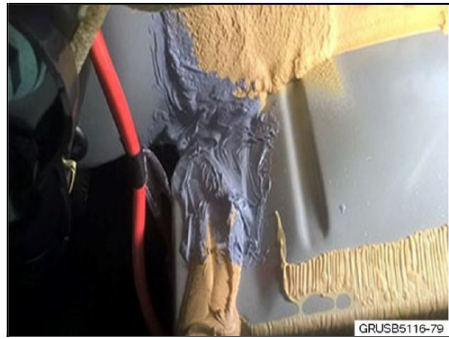
View of the rear right wheel arch after rework.
