## TRAFFIC JAM ASSISTANT BECOMES INOPERATIVE DURING USE

G12 (7 Series)
ZDT – Driver Assistant Plus II includes “Traffic Jam Assistant (ZN9)”

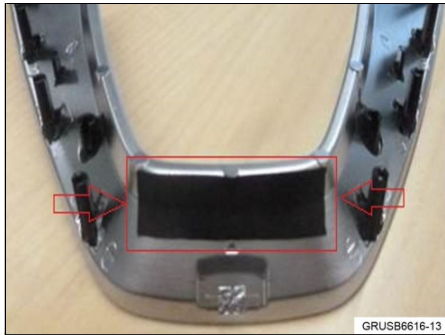
Vibration actuator causes inadvertent contact between steering wheel trim and steering wheel, changing capacitance of steering wheel beyond acceptable parameters for Hands-Off detection.

2. Remove the steering wheel cover according to REP 3233016 “Cover for sports steering wheel”.
3. Attach a 40 mm long piece of the tape with the part number 61 13 2 359 177 to the inner cover where shown in the following graphic.
