## SOS MALFUNCTION DISPLAYED

F22 (2 Series Coupe),	F30 (3 Series Sedan)	F31 (3 Series Sports Wagon)	F32 (3 Series Coupe)
F34 (3 Series Grand Turismo)	F80 (M3 Sedan)	F82 (M4 Coupe)	G12 (7 Series Sedan)

Produced from July, 2015

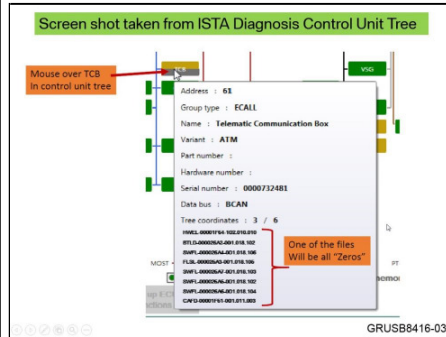
## 1. Diagnose with ISTA.

- Using the mouse, hover cursor over the ATM/TCB2 in the control unit tree.
- Look at the list of software files. **Does one of the filenames display as all “Zeros”?**

YES- Remove the ATM/TCB2 control module as outlined in REP 65 20 037 – Remove and install/replace roof-mounted aerial with telematics control unit. Go to step 4 when complete.

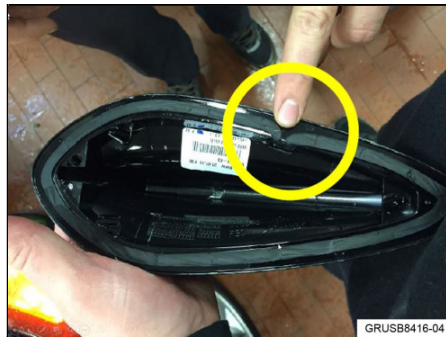
- Picture shows a space/gap in the seal of the shark fin that would cause leakage.

- Remove and reinstall the shark fin following REP 65 20 030.

Note: The repair instructions contain the procedure on cleaning and resealing the shark fin.

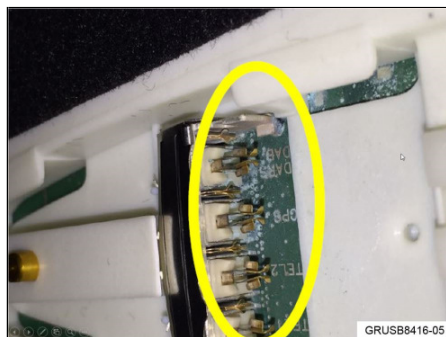
- This picture shows corrosion on the contact of the ATM/TCB2 control unit.

## 2. Remove and replace the ATM/TCB2 as per REP 65 20 037
