GROANING NOISE WITH CLUTCH OPERATION

F54 (Cooper S Clubman)	F55 (Cooper, Cooper S Hardtop 4 door)	F56 (Cooper, Cooper S Hardtop 2 door)	F57 (Cooper, Cooper S Convertible)
------------------------	---------------------------------------	---------------------------------------	------------------------------------

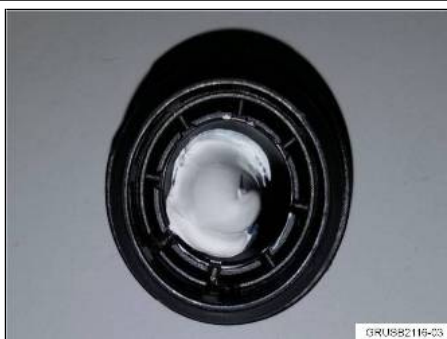
Friction between clutch slave cylinder piston rod end and ball socket (thrust piece).

4. Clean the surfaces free of dirt.

5. Grease the socket for the piston rod end, in the thrust piece, with lubricant specified below.
