SI M51 12 16
Body

SERVICE ACTION: RUBBER STRIP ON REAR SIDE WINDOW TRIM IS CRACKED

F54 (Cooper S Clubman)

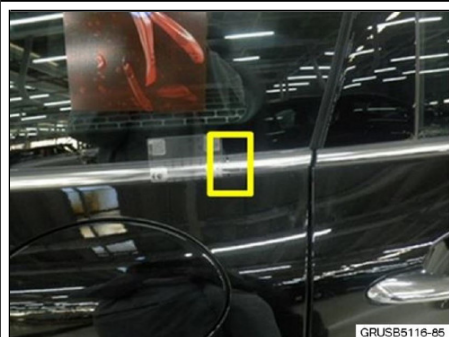
The rubber strip on the rear side window trim may crack. In some cases a gap may be evident on the rubber trim strip.

1. Check the rubber strip on the trim below the fixed rear window. **Is the rubber strip cracked?** YES- replace the trim strip following **REP 51 36 040** "Removing and installing/replacing strip on rear left or right side window". NO- Go to next step 2.

Inspect and replace, if any crack is evident. Make sure part is index 08, or higher.

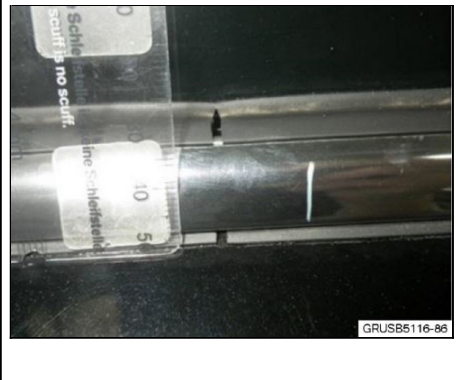
<p>2. Repeat step 1 on other side. If no crack is found, the parts do not need to be replaced.</p>
---	--

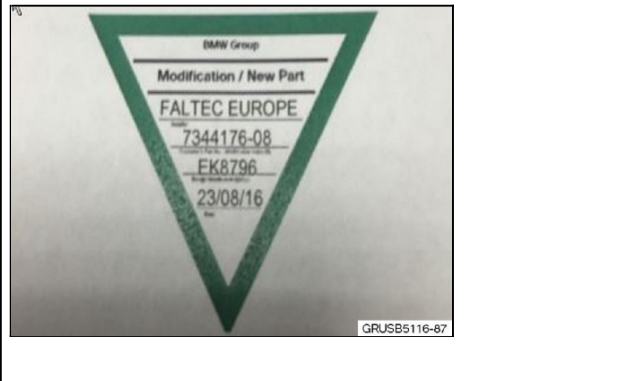
Note: Only parts with the following identification may be installed:

Marking on box, or	Marking on part (red mark), or
