## HORN DOES NOT WORK

| F54 (Cooper S Clubman) | F55 (Cooper, Cooper S Hardtop 4 door) | F56 (Cooper, Cooper S Hardtop 2 door) | F57 (Cooper, Cooper S Convertible) |

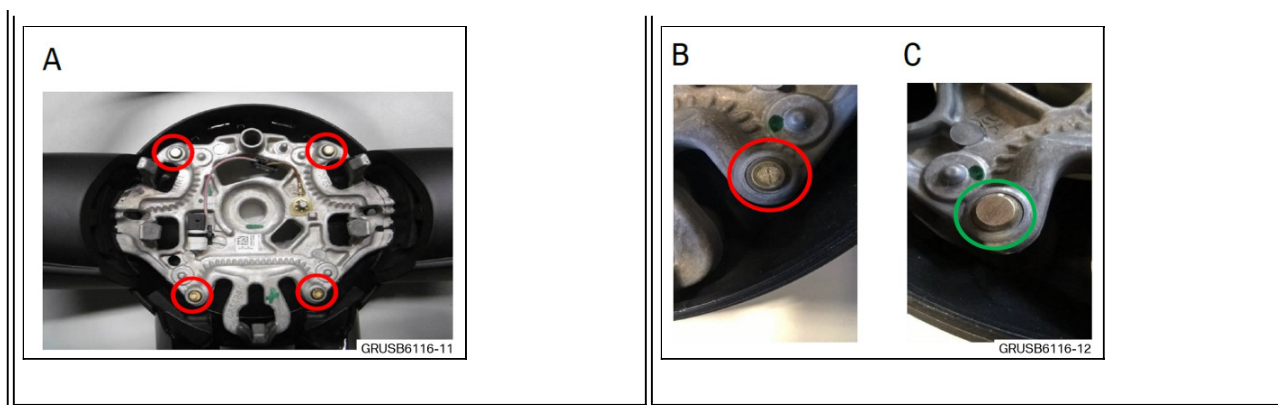
Dissimilar metal corrosion between horn switch contacts and airbag unit.

1. Remove the airbag unit in accordance with REP 32 34 020 "Remove and refit/replace the airbag unit."
2. Remove corrosion from all four contacts (see Figure A) using sandpaper of 400 grit or higher (see Figure B) until contacts are shiny (see Figure C). It is not necessary to clean the wire for the horn at the airbag unit.
