SERVICE ACTION: REWORKING THE PHEV SCREW CONNECTION OF THE COOLANT LINE ON ELECTRICAL MACHINE ELECTRONICS

G12 (740e xDrive iPerformance)

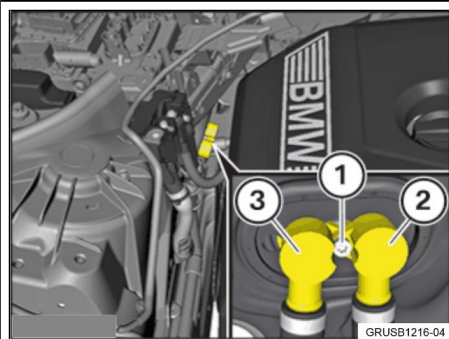
The screw connection of the coolant lines to the electrical machine electronics (EME) may not have been properly tightened.

Incorrect torque applied during installation.

Re-torque the screw (1) to 8Nm.

Note: Opening of the cooling circuit is not required.
