SI B33 06 16  
Rear Axle

## SERVICE ACTION: CHECK AND REPLACE THE LEFT REAR AXLE SHAFT

I12 (i8)
----------

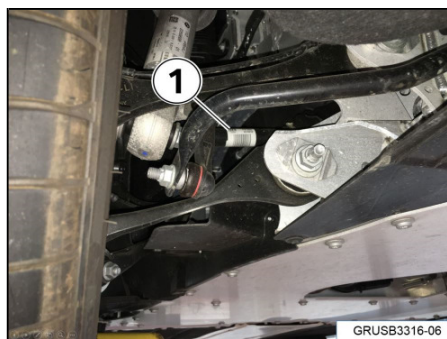
1. Raise the vehicle to access the parts label on the left rear axle (1).

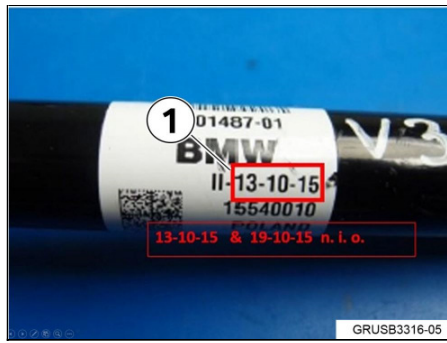
Rear axle shafts marked with production date code 13-10-15 or 19-10-2015 have been improperly manufactured.

2. Inspect the date code on the left rear output shaft (DD-MM-YY) (1). **Is the production date code either 13-10-15 OR 19-10-2015?**

YES- Replace the shaft. Follow Repair Instruction **REP 33 21 001** "Removing and installing /replacing left output shaft".

NO - Release the vehicle.
