DOOR FRAME TRIM DAMAGED

F34 (3 Series Gran Turismo)	F36 (4 Series Gran Coupe)
Vehicles produced from June 1, 2013 through November 11, 2014

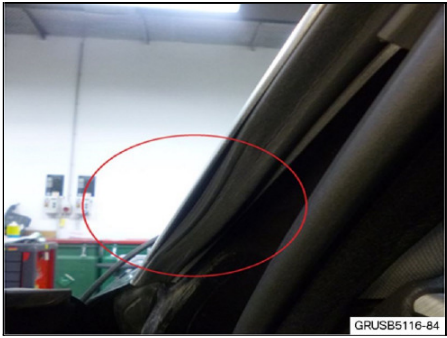
<p style="text-align: right; font-size: small;">GRUSB5116-84</p>	<p>

Door seal on the A-Pillar is damaged near exterior mirror.

Note: Deformed A-pillar door seal near side view mirror</p>
---	---

Mirror base gasket protrudes and interferes with door seal.

Replace side frame strip and window glass on affected side.

1. Replace side frame strip including door seal following REP 51 13 316 "Removing and installing or replacing trim strip on roof gutter at left or right".
2. Remove and replace front door window glass (necessitated by change in trim design) following REP 51 32 170 "Removing and installing/replacing door window glass, front left or right".
3. Align the front door window glass following REP 51 32 154 "Adjusting left or right front side window"
4. Reassemble remaining parts as per instructions.
