SERVICE ACTION: CHECK RIGHT SIDE REAR DOOR FOR WATER LEAK TIGHTNESS

F30 (3 Series Sedan)	F31 (3 Series Sports Wagon)
----------------------	-----------------------------

This Service Action involves F30, F31 (3 Series) models produced in August 2015.

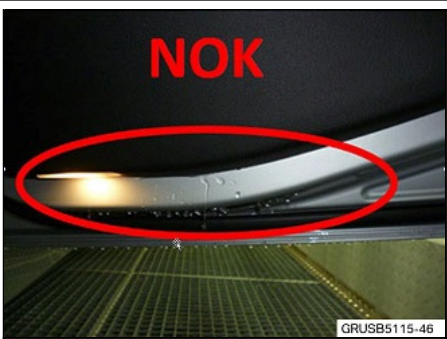
The right rear door sound insulation may not have been applied correctly and can cause water leaks.

<p>GRUSBS115-46</p>	<p>4. If water is found, replace the sound insulation. Use Repair Instructions REP 51 48 070 Removing and installing/replacing sound insulation on left or right rear door.</p>
