REVERSE LIGHT SHINES INTO PASSENGER CABIN

F48 (X1 sDrive 28i or xDrive 28i)
Produced from February 29, 2016 to August 25, 2016

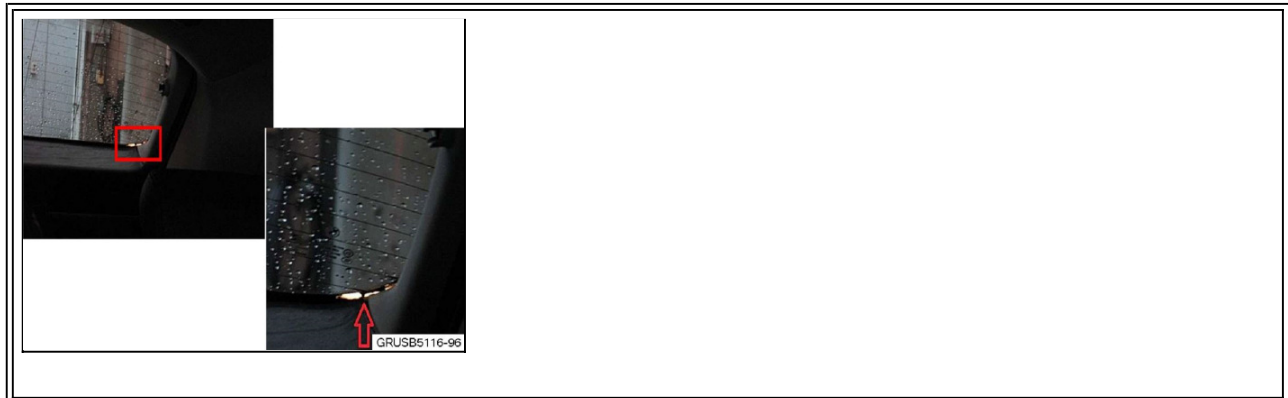
Reverse light shines into passenger cabin at the rear window and glares into driver's eyes from interior rearview mirror.

Deletion of light cover.

Install light covers.

1. Remove tailgate trim panel following REP 51 49 000 "Removing and installing/replacing the tailgate trim panel;"
2. Attach the light cover on one side as shown in the attached video; then
3. Attach opposite side cover
4. Re-install the tailgate trim panel
