SI B63 07 16  
Lights

## WATER INSIDE REAR LIGHT ASSEMBLY

| F22 (2 Series Coupe) | F23 (2 Series Convertible) |

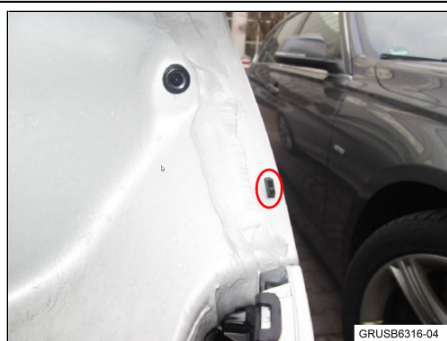
Water is inside rear light assembly.

Water is drawn into the rear light assembly through ventilation openings.

1. Remove the rear light on both sides according to ISTA REP 63 21 260 "Removing and installing (replacing) left/right rear light".

2. Detach the spacers on both sides of the vehicle body if present and dispose of them.

3. Obtain new (modified) rear lights (same part number). Updated part has no black cap on bulb socket.
