## WATER DRIPPING INTO LUGGAGE COMPARTMENT FROM OPEN TRUNK LID

F30 (3 Series Sedan)	F80 (M3 Sedan)
LCI from 7/1/15.

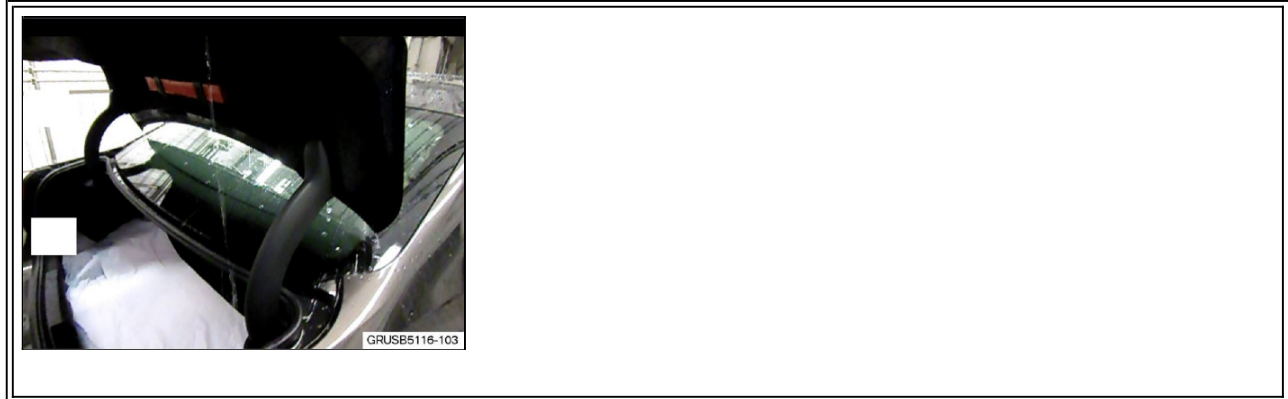
Water drips into luggage compartment when the trunk lid is lifted (also see attached video below).  
[www.tinyurl.com/F30trunk](http://www.tinyurl.com/F30trunk)

Water trapped between the tail light module and the body of the vehicle.

Add butyl rope between tail light module and body of vehicle to block the water.
