DRIVER'S SEAT GROANS/CREAKS UNDER LOAD

F48 (X1)	
Vehicles with option code SA 481 Sport seats	Vehicles produced between: July 01, 2014 to September 16, 2016

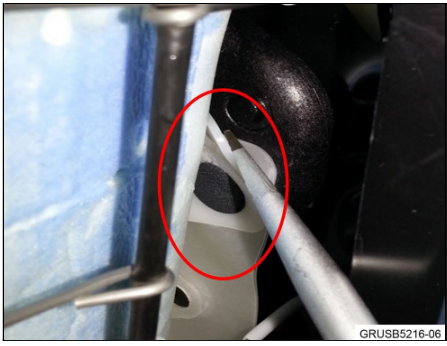
2. Press into the seatback while putting light pressure on the lumbar support or fastening clip.

Does the light pressure on the support or clip eliminate the noise?
