SME FC 21F284 “HIGH-VOLTAGE BATTERY UNIT, CELL SUPERVISION CIRCUIT: SAFETY CIRCUIT ACTIVATED”

| I01 (i3 and i3 REx) |

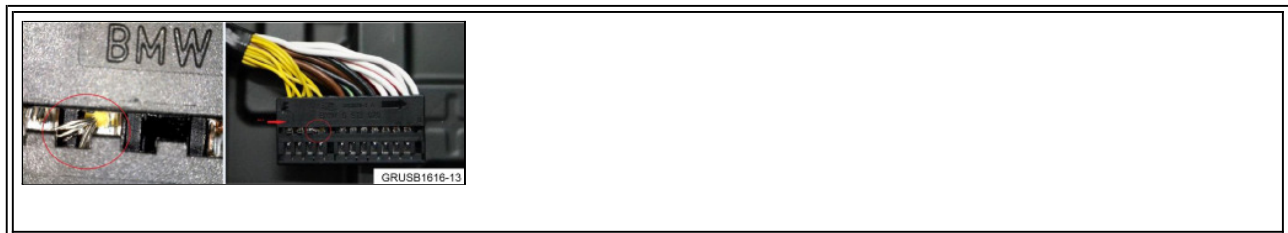
3. Check the crimping of the pins at the cell module 12 volt connector.

Does the crimping show evidence of misalignment or possible shorting (see graphic)?

YES- Replace the suspect cell module, the corresponding CSC and the CSC wiring harness according to repair instructions.

NO - Replace all CSC's and the CSC wiring harnesses according to repair instructions.
