HEADLIGHT ASSEMBLIES HAVE VISIBLE INTERNAL MOISTURE/CONDENSATION

F01 (7 Series Sedan)	F02 (7 Series Sedan LWB)	F04 (7 Series Hybrid)	F06 (6 Series Gran Coupe)
F07 (Gran Turismo)	F10 (5 Series Sedan)	F12 (6 Series Convertible)	F13 (6 Series Coupe)
F15 (X5)	F16 (X6)	F22 (2 Series Coupe)	F23 (2 Series Convertible)
F25 (X3)	F26 (X4)	F30 (3 Series Sedan)	F31 (3 Series Sports Wagon)
F32 (4 Series Coupe)	F33 (4 Series Convertible)	F34 (3 Series Gran Turismo)	F36 (4 Series Gran Coupe)
F48 (X1)	F80 (M3 Sedan)	F82 (M4 Coupe)	F83 (M4 Convertible)
F85 (X5 M)	F86 (X6 M)	F87 (M2)	G12 (7 Series Sedan)
I01 (i3)	I12 (i8)

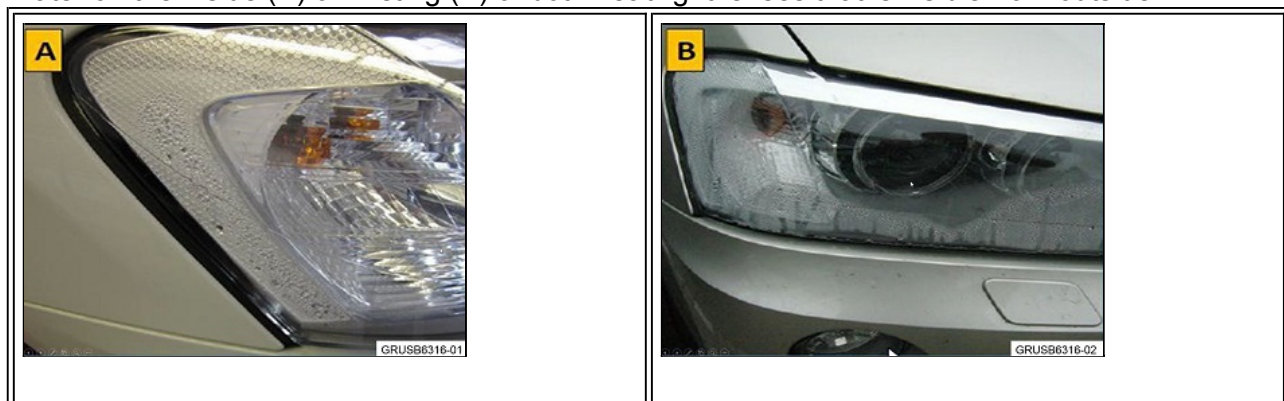
Water on the inside (A) or misting (B) of both headlight lenses that is visible from outside.

Water inside the headlights can be caused by two situations:

- Water/moisture ingress into the headlight housing.
- Thermal conditions that result in the formation of condensation.

Note: An important indication that the moisture issue is caused by “condensation”

rather than a “water leak” into the headlight housing, there will be misting/condensation in “both headlights.”

- Dry out both headlights.
- **Only** if there is a permanent stain then replace the affected headlight.
