## AIRBAG WARNING LAMP ILLUMINATED

This Service Information bulletin Replaces SI B65 18 16 **dated July 2016**.

I01 (i3)
----------

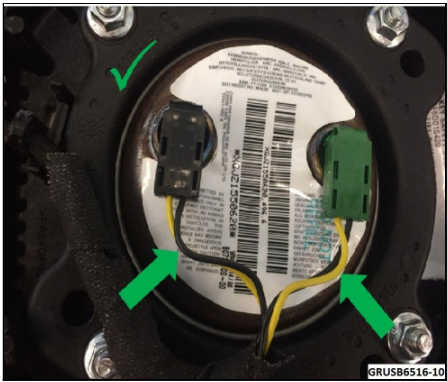
Correct tension free routing
--	------------------------------

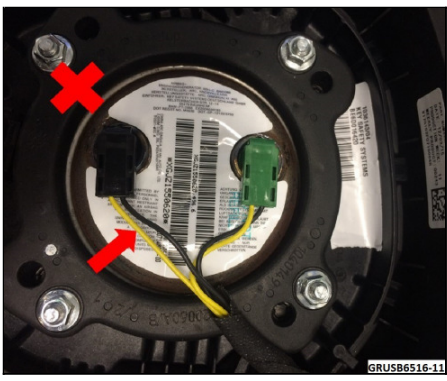
Tension caused by harness cable tie on short jumper harness located between steering column slip ring and driver's airbag creates excess resistance.

<p>Incorrect routing. The yellow wire is under tension.</p>

Replace driver's airbag module **OR** change tension on harness.
