FM RADIO INTERFERENCE

F56 (Hardtop 2 Door) Models with SA0674 HK Hi-Fi speaker system

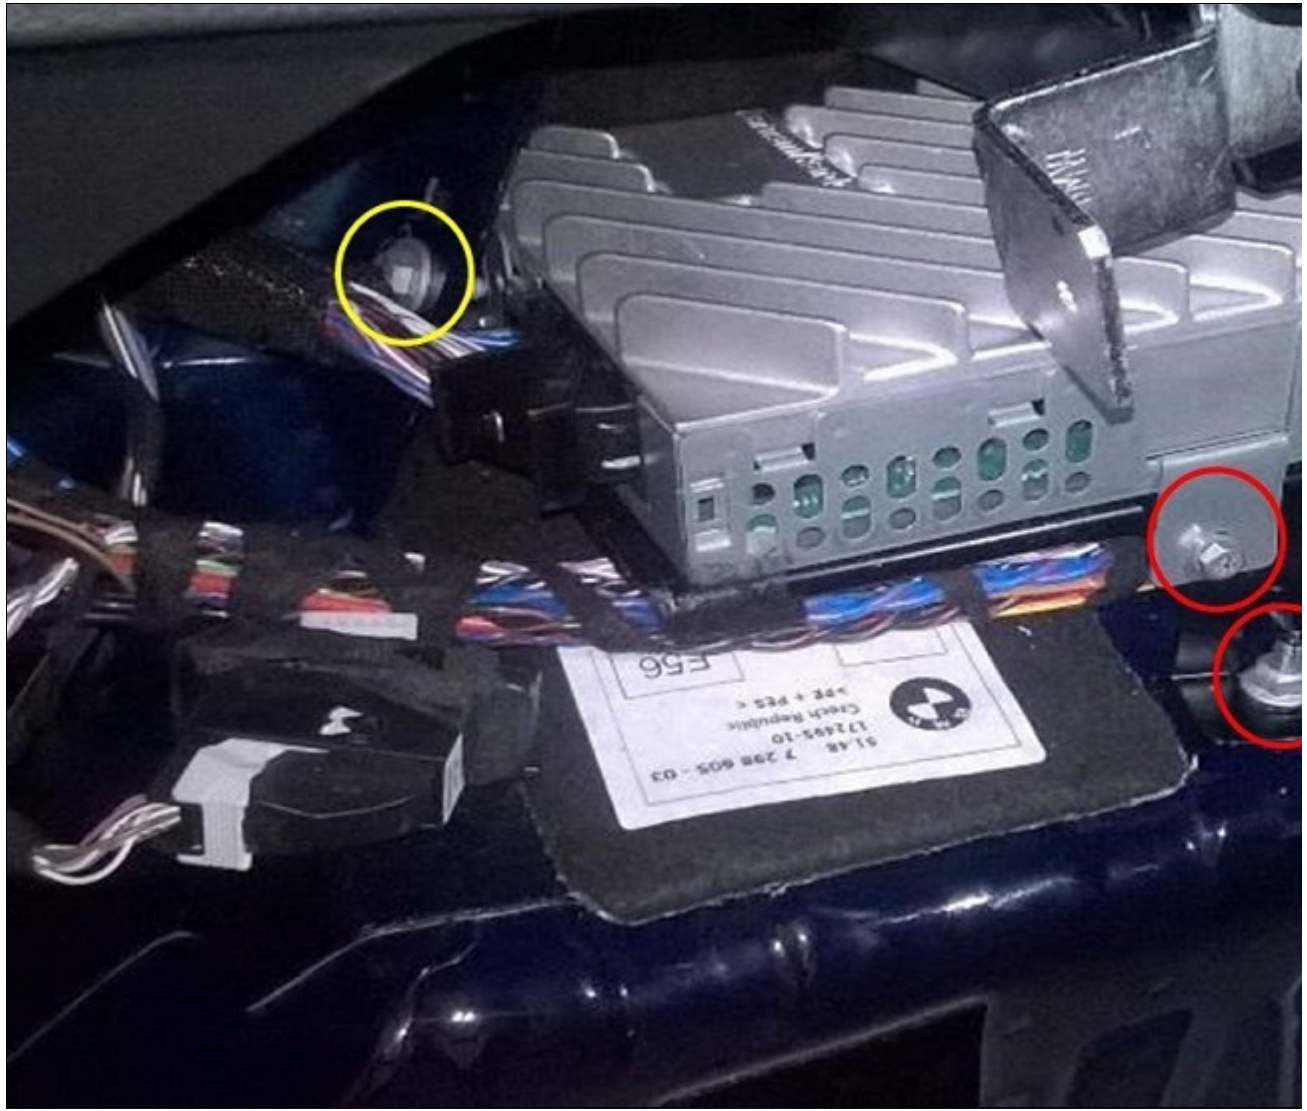
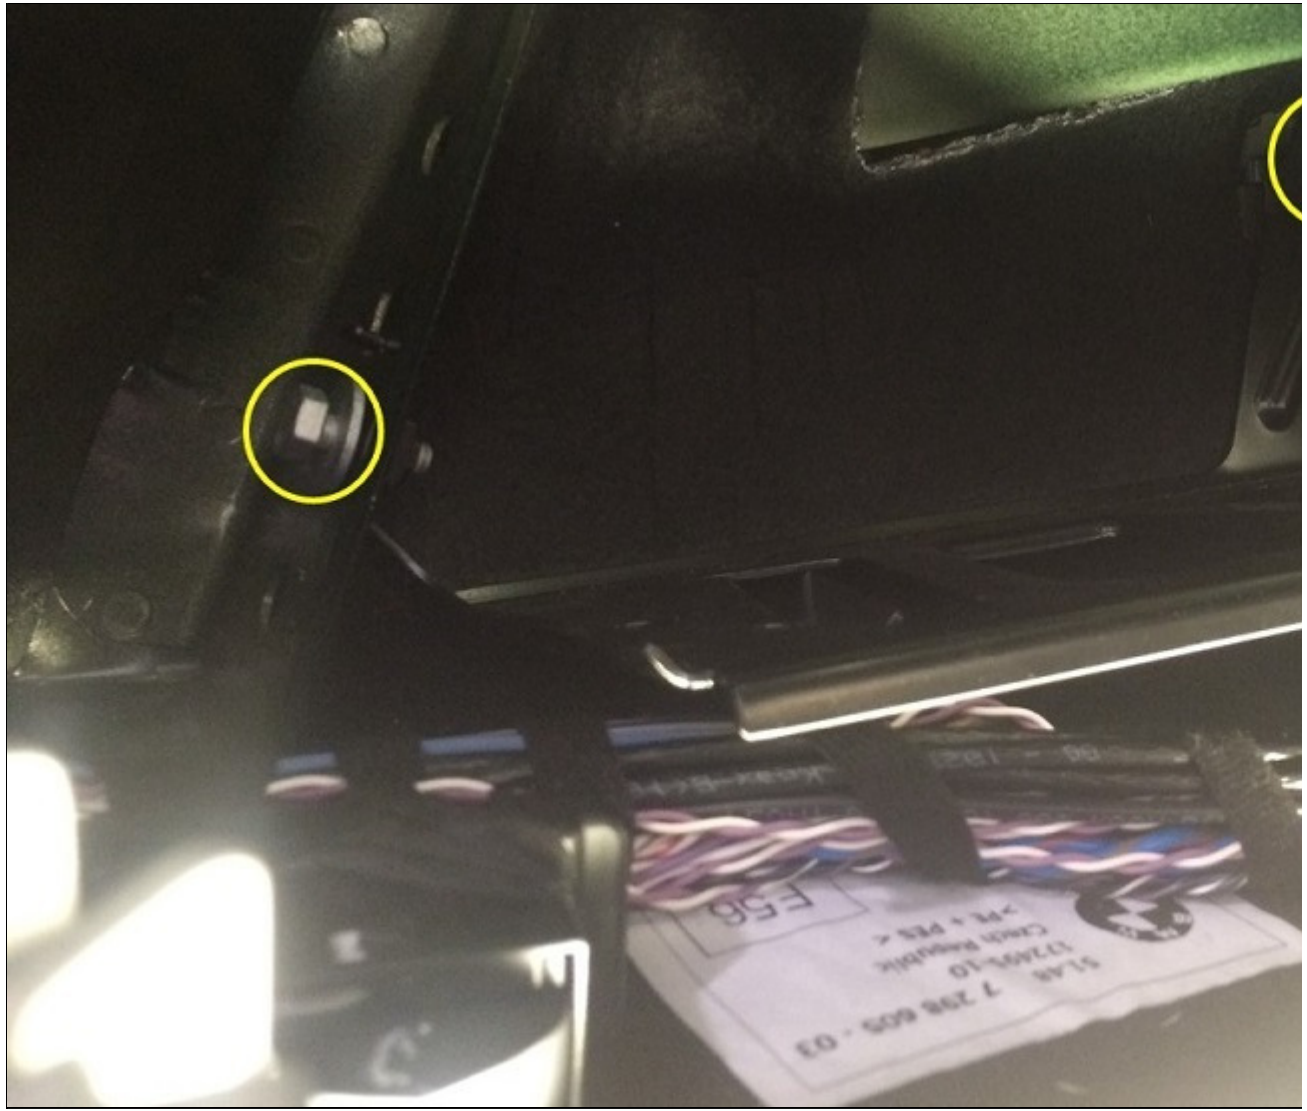
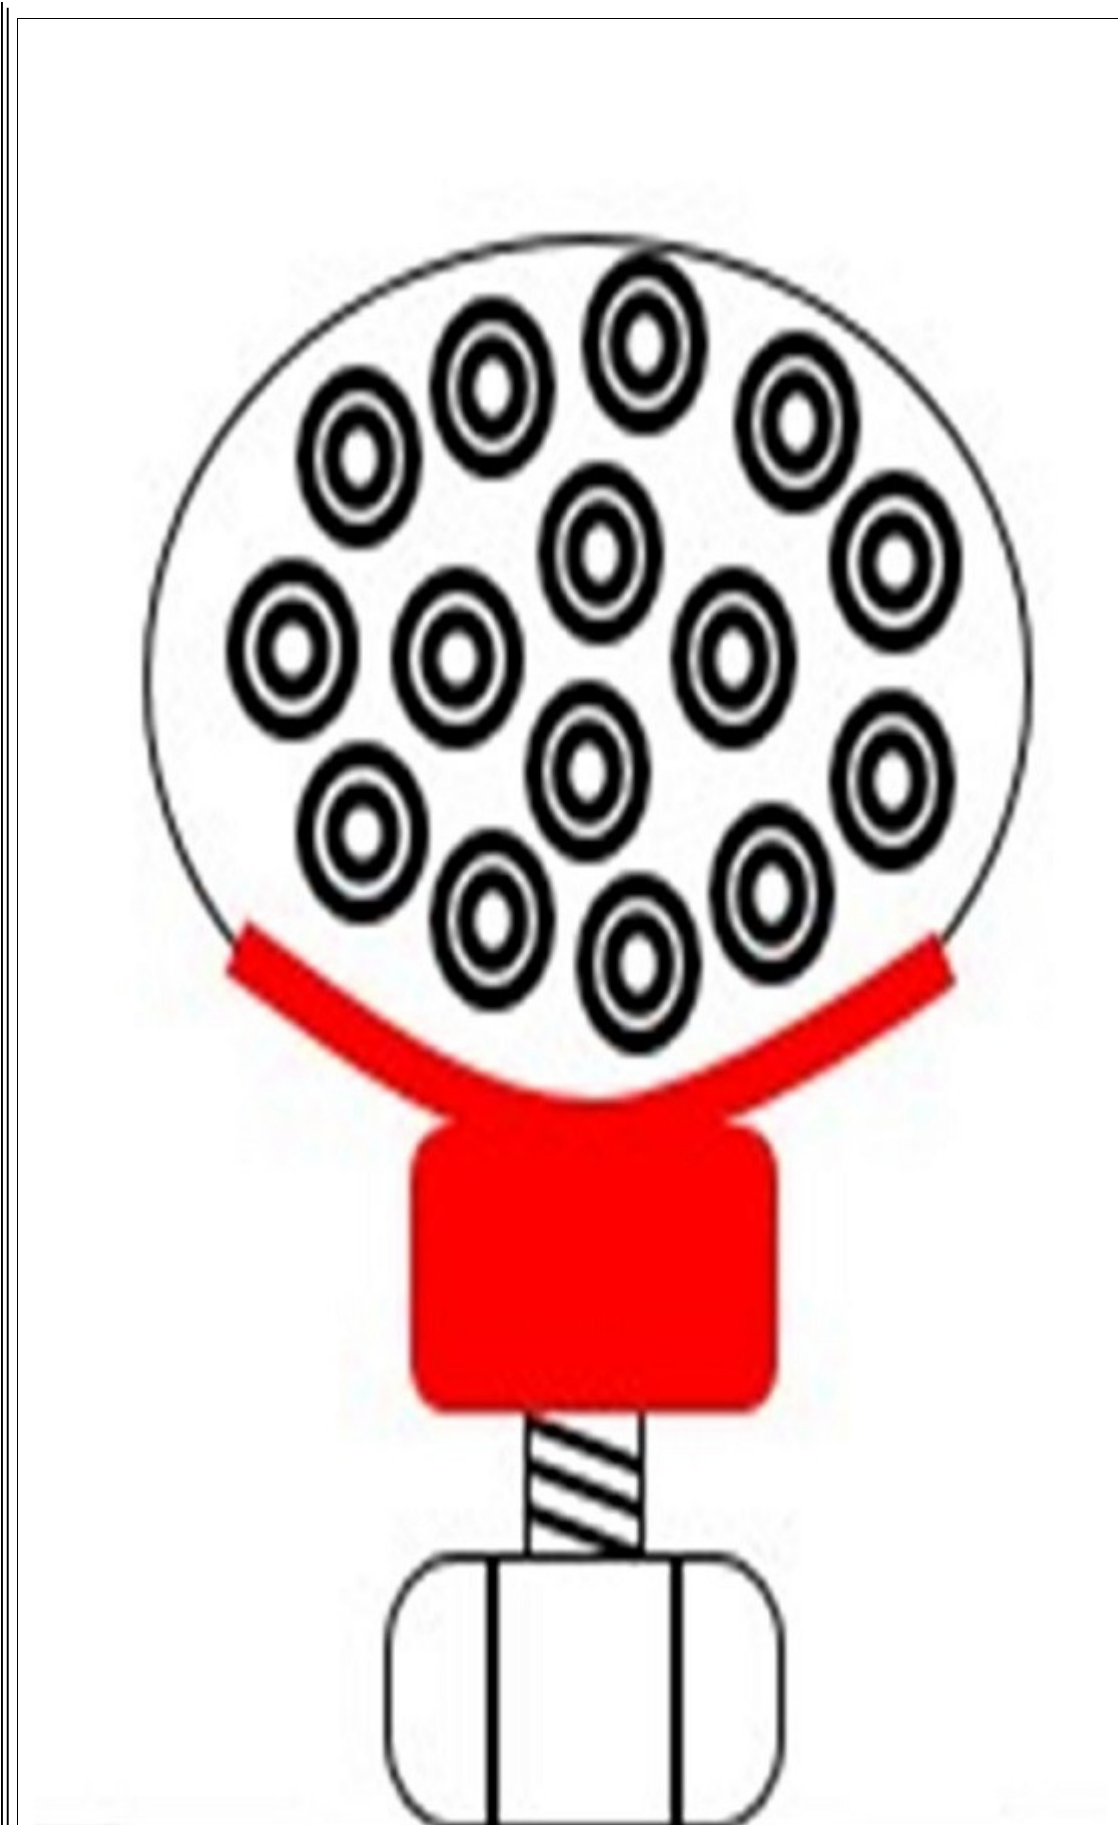
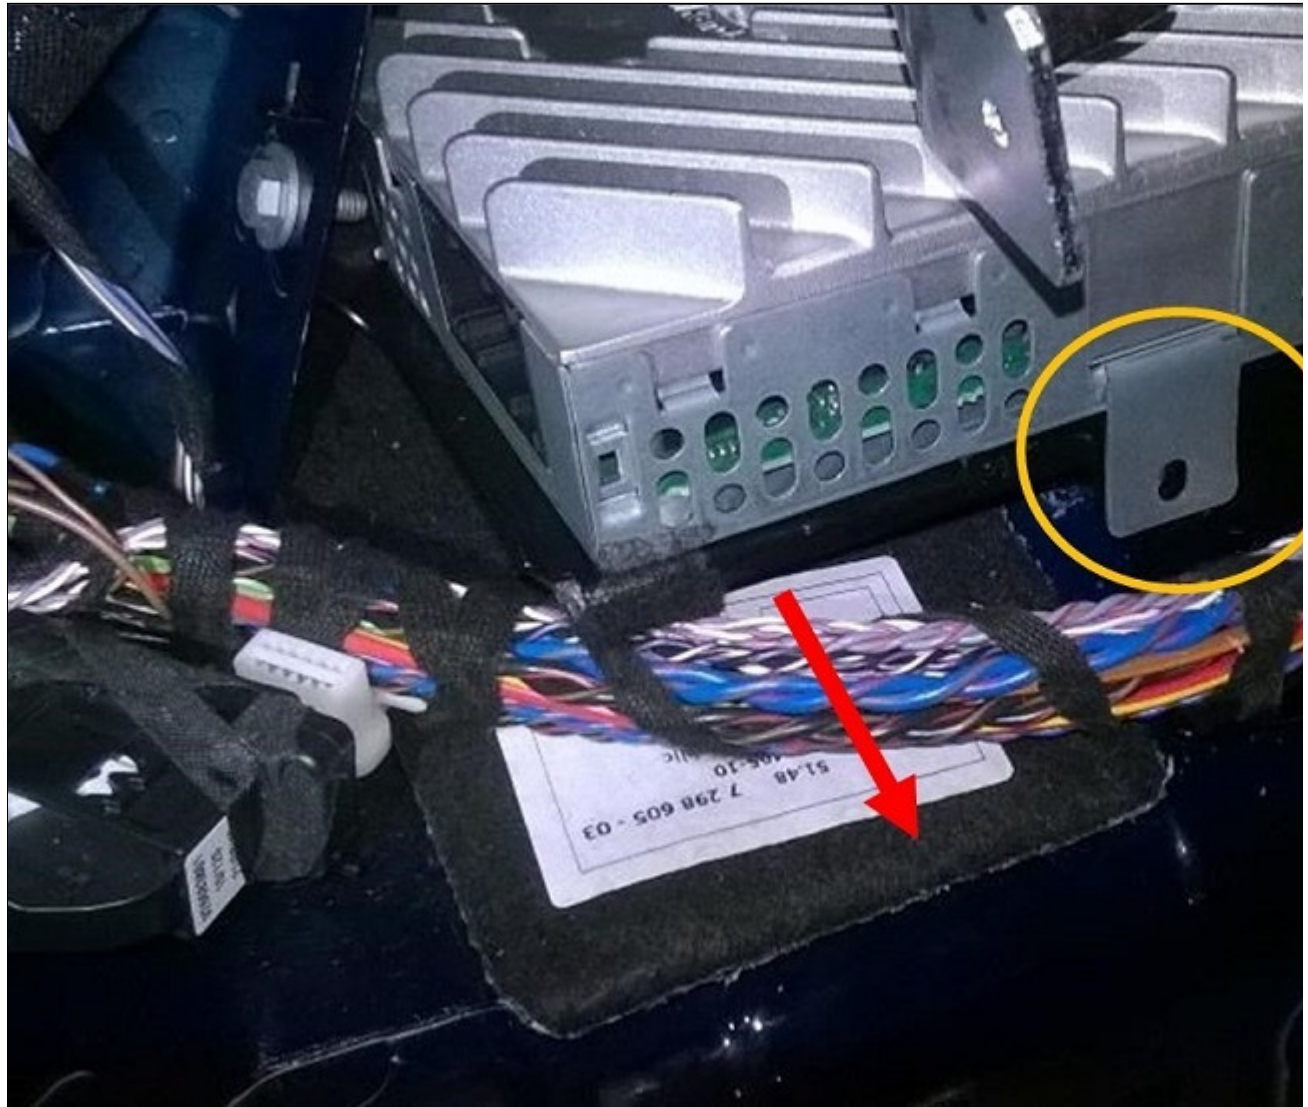
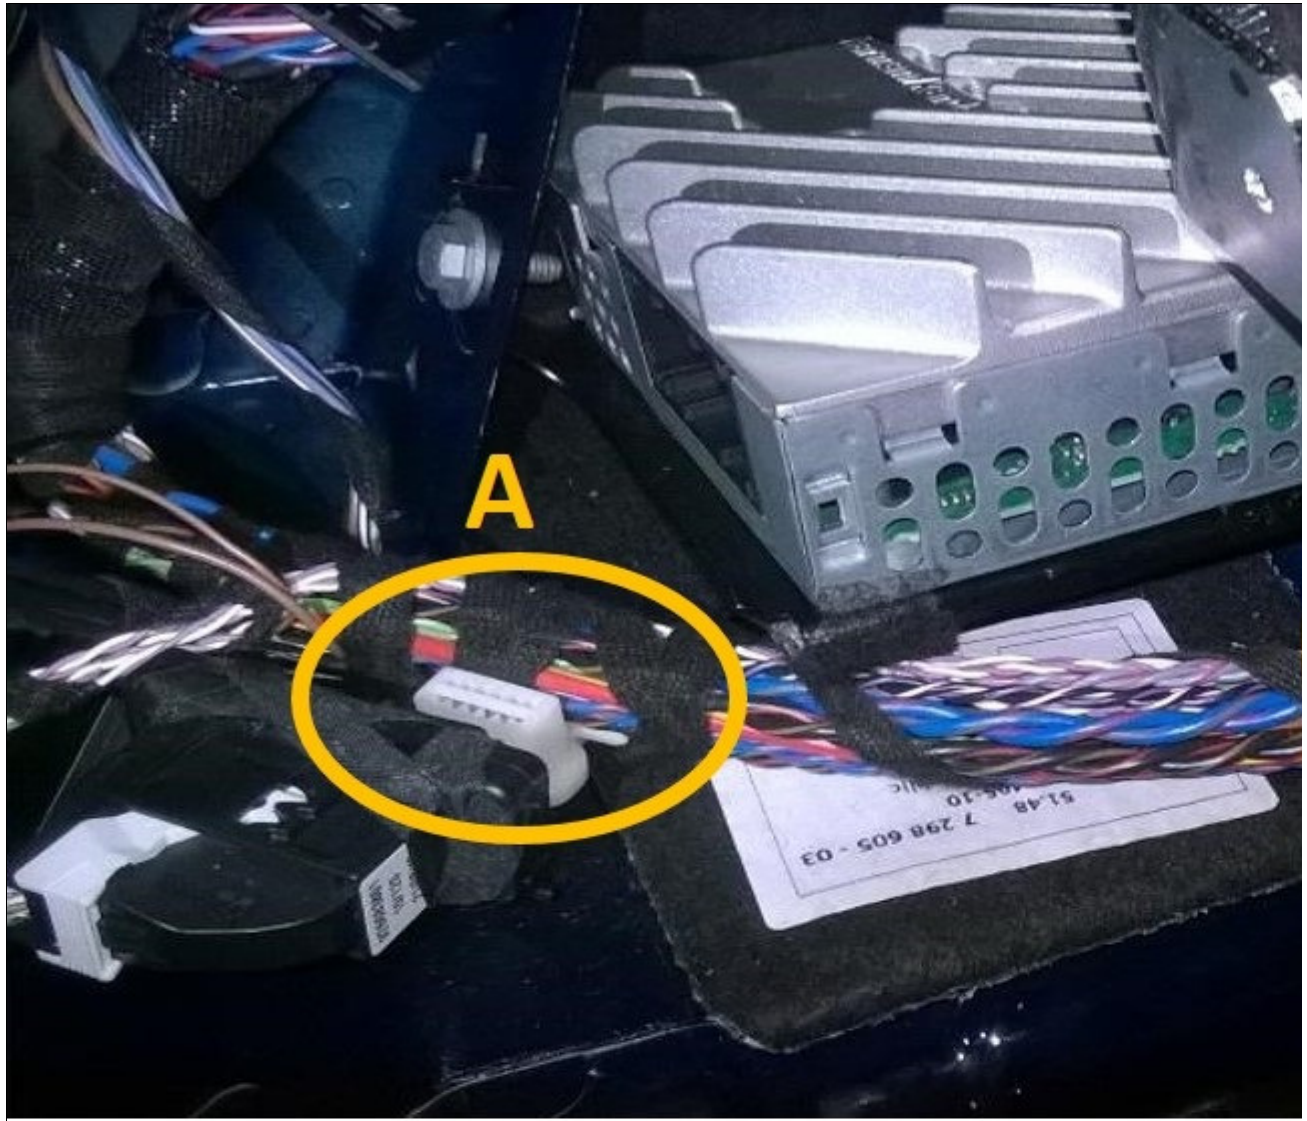
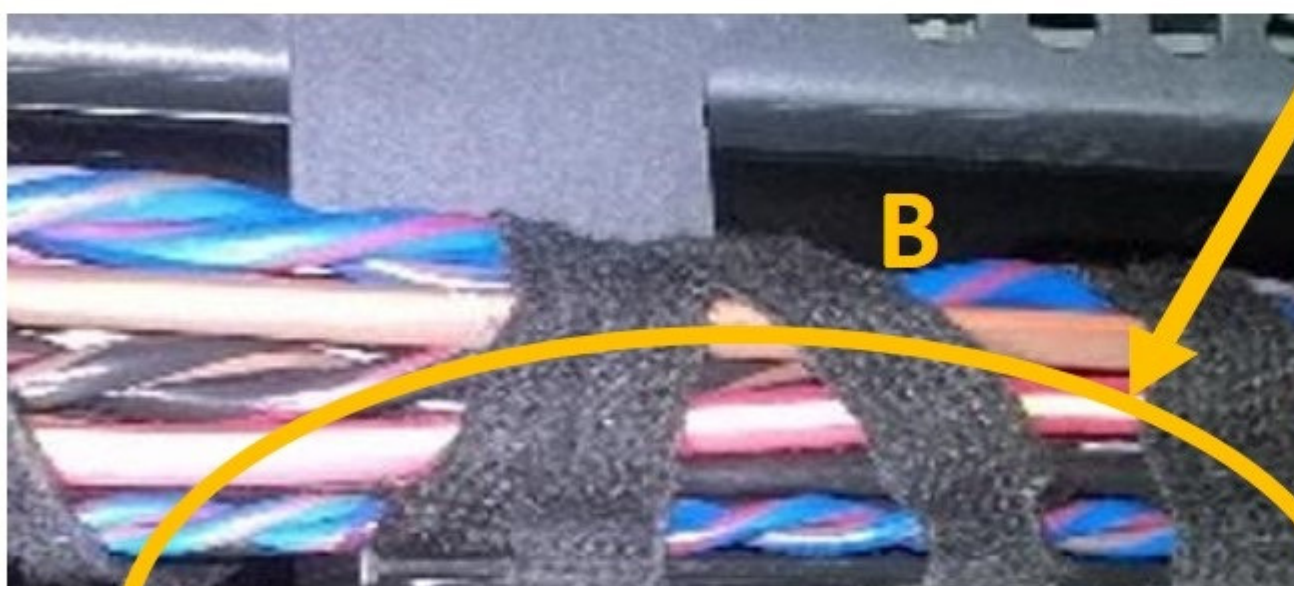
The wire harness which is run underneath the amplifier may be influenced by Electro-magnetic interference (EMI) from the amplifier. This can generate noise(s) under certain circumstances.

Change routing of wiring harness to remove it from area of strong EMI.

- **NO** – Locate the amplifier in the luggage compartment above the rear left wheel well.
