## NOISES WHEN TURNING THE STEERING WHEEL

This Service Information bulletin supersedes SI 32 03 15 dated January 2016.

I01 (i3, i3 REx) produced from 8/31/13 to 11/2/15

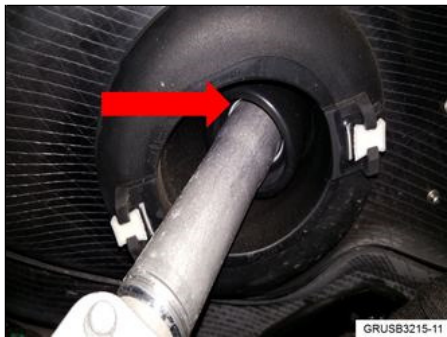
There are squeaking or groaning noises from the steering spindle when the steering wheel is turned.

The steering spindle sleeve's plastic bearing is insufficiently lubricated or not lubricated at all.

1. Lubricate the engine compartment side of the steering spindle-
  - a. Refer to REP 51 64 050 "Removing and installing/replacing front luggage compartment well" to gain access to the steering shaft bearing.
  - b. Lubricate the plastic ring of the sleeve on the steering shaft with the following agent: Universal plastic lubricant (BMW P/N 81 23 2 327 735).
  - c. To complete, distribute the lubricant by turning the steering left and right, and then repeat this operation three times.
2. 2. Lubricate the under-dash portion of the steering spindle.
  - a. Refer to REP 51 45 184 "Removing and installing/replacing trim panel for pedal mechanism" to gain access to the steering shaft
