SI B33 04 16
Rear Axle

August 2016
Technical Service

SERVICE ACTION: REPLACE REAR-AXLE DIFFERENTIAL

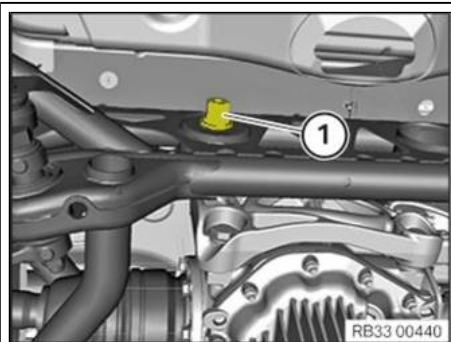
During the repair, when releasing rear differential Hexagonal collar bolt M14x1.5x125 (PN 33 17 7 852 488), make sure that the bolt's hex head does not show any marks indicating previous removal. In case bolt M14x1.5x125 (1) has been removed (torque released) previously, it needs to be replaced together with 4 sub-frame Torx screws M12x60 (PN 33 30 2 284 642).

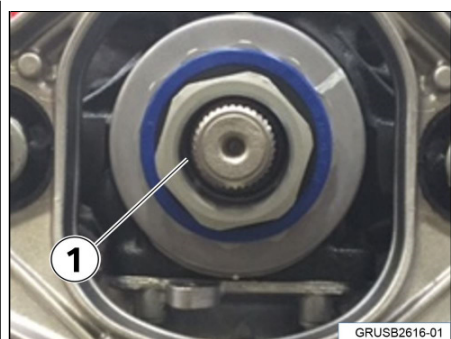
F8x produced up to 06/28/2016

<p>Identifying the 8 090 464 differential: Check the number of splines on the old/new differential. The correct differential has 35 splines (1)</p>
--	--

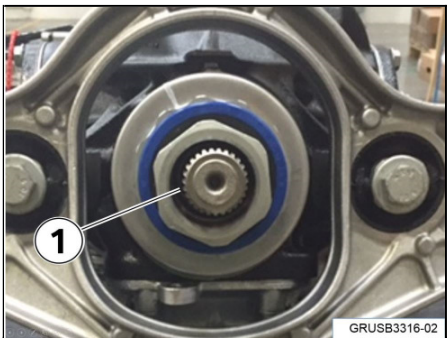
F8x produced from 06/29/2016

<p>Identifying the 8 090 473 differential: Check the number of splines on the old/new differential. The correct differential has 27 splines (1)</p>
---	--
